# Model Communiqué

Communiqué # 113

### **ATA 22 Autopilot – G36/G58 Garmin GSM 85 Servo Mount Inspection Service Bulletin**

NO.: 0713 Revision B

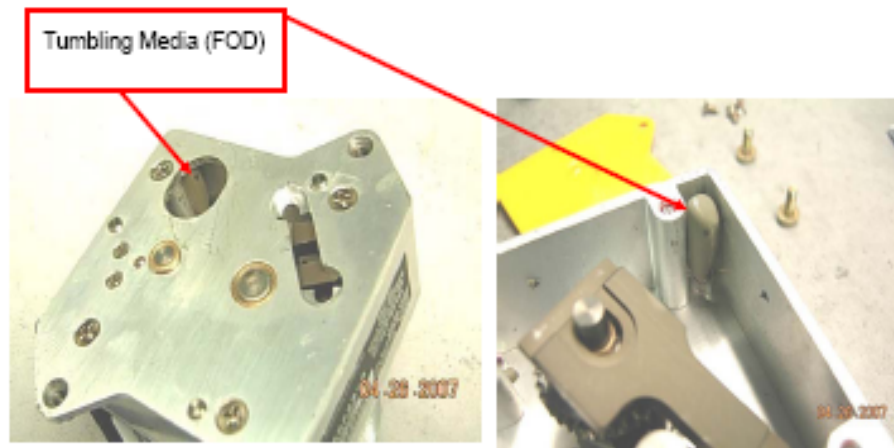
Figure 4-1

- 4.5 If the borescope inspection produces no conclusive determination regarding the absence of FOD, proceed to Section 5 FOD Inspection by GSM Removal.
- 4.6 If it is conclusively determined that no FOD is present:
- o For GSM 85s part number 011-00894-00 or 011-00894-10 only, mark the MOD 3 circle (on the serial tag) with an indelible marker indicating compliance with this bulletin.
  - o For GSM 85s part number 011-00894-XX (where -XX is other than -00 or -10), mark the MOD 1 circle (on the serial tag) with an indelible marker indicating compliance with this bulletin.

- 4.4 If FOD is present, remove the GSM 85 per the OEM Aircraft Maintenance Manual and return the GSM 85 servo gearbox to Garmin for exchange. After receiving the replacement GSM 85 from Garmin, proceed to Section 6 Reinstallation.

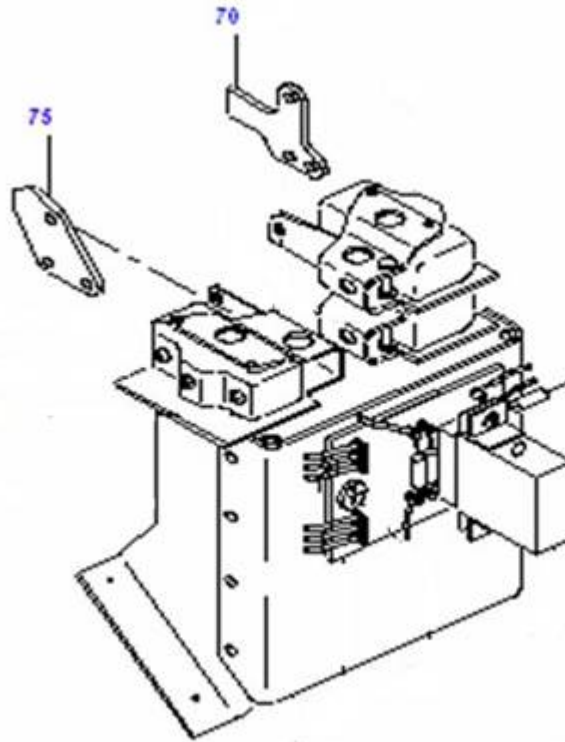
It is permissible to adjust the upper section only of arm item number 75 (part # 002-364013-13) +/- 3 degrees to help in achieving the adjustment on the limit switches for the gear rigging. Make sure that the two arms item #75 and #70 do not interfere with one another. The above figure may be found in section 24-00-00-07 of the current Bonanza IPC on IML (Interactive Maintenance Library – formerly known as REPS).
