WINGS - INSPECT WING NACELLE KEELS FOR MISSING RIVETS

G58

MEL-57-03  
Page 1 of 8

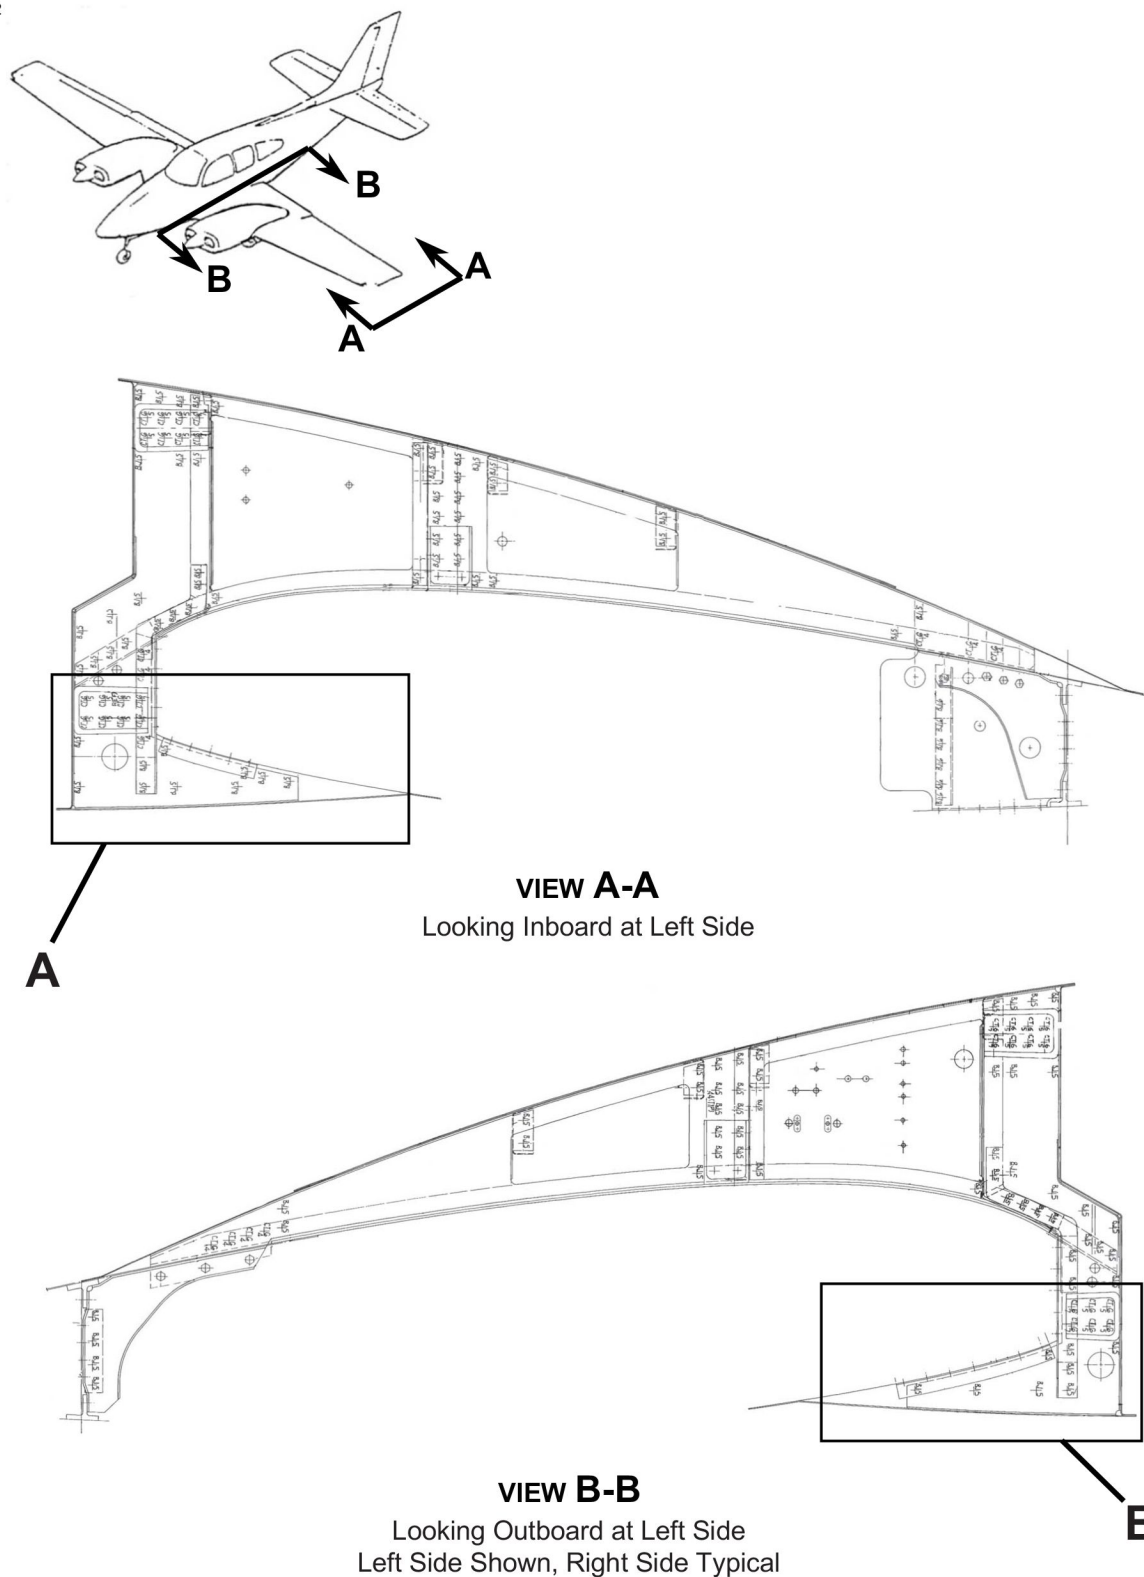
Figure 1. Keel Rivet Inspection (Sheet 1)

4. (Refer to Figure 1, Detail A, Detail B, View A-A, View B-B and Figure 1, Sheet 5 and Sheet 6.) Inspect the left wing inboard and outboard nacelle keel.

- A. If all of the rivets shown are installed, go to Step 4.B.
    - (1) Make sure the eight rivets shown are installed.
    - (2) If any of the rivets are not installed, do the steps that follow:

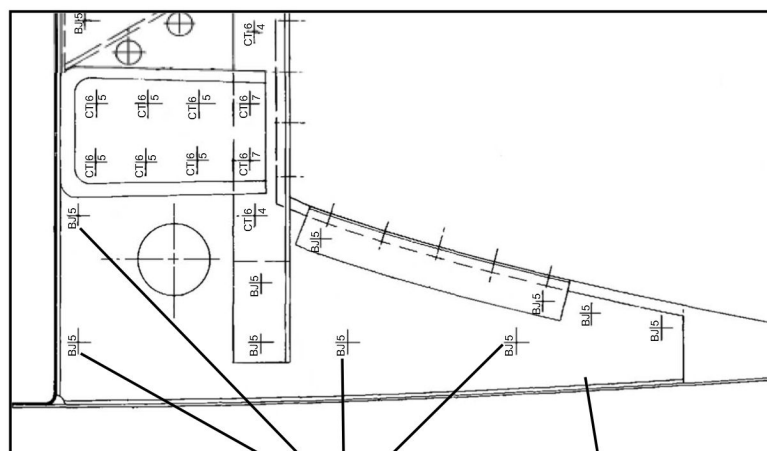
**DETAIL A**

Number 21  
(0.159 inch-diameter) Hole  
CR3523-5-03  
Rivet  
(As Required)

Keel  
(Reference)

**NOTE:** It may be necessary to remove the cushioned steel band clamps that attach the wire bundle to the aft side of the firewall to improve access for drilling and riveting.
      - (b) Layout and drill the Number 21 (0.159 inch-diameter) holes through the keel as required.
      - (c) Deburr the holes that were drilled.
      - (d) Apply Alodine 1201 Color Chemical Film Treatment to the holes that were drilled.
      - (e) Apply epoxy primer to the holes that were drilled.

- (f) Install the CR3523-5-03 Rivets wet with epoxy primer as required in the keel.

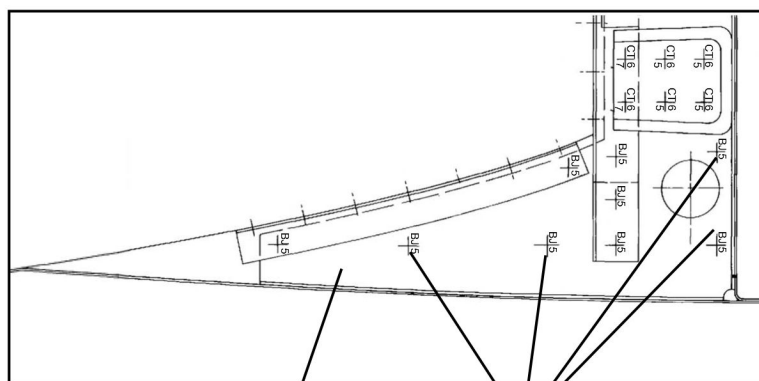
**DETAIL B**

Keel  
(Reference)

Number 21  
(0.159 inch-diameter) Hole  
CR3523-5-03  
Rivet  
(As Required)

Left Side Shown,  
Right Side Typical
