**ADs 90-08-04 / 95-04-03**  
**MSBs 53-2269 / 2360**

**Carry-Thru Spar Web Cracks**  
**American Bonanza Society/  
ABS Air Safety Foundation**

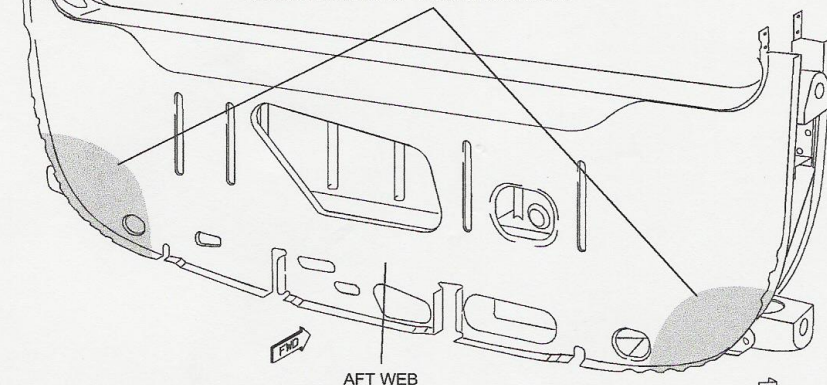
INSPECT FOR CRACKS AROUND HUCKBOLTS AND BETWEEN HUCKBOLTS AND ALONG THE RADIUS OF THE CARRY-THRU WEB AS INDICATED BY THE SHADED AREAS OF THE ILLUSTRATION

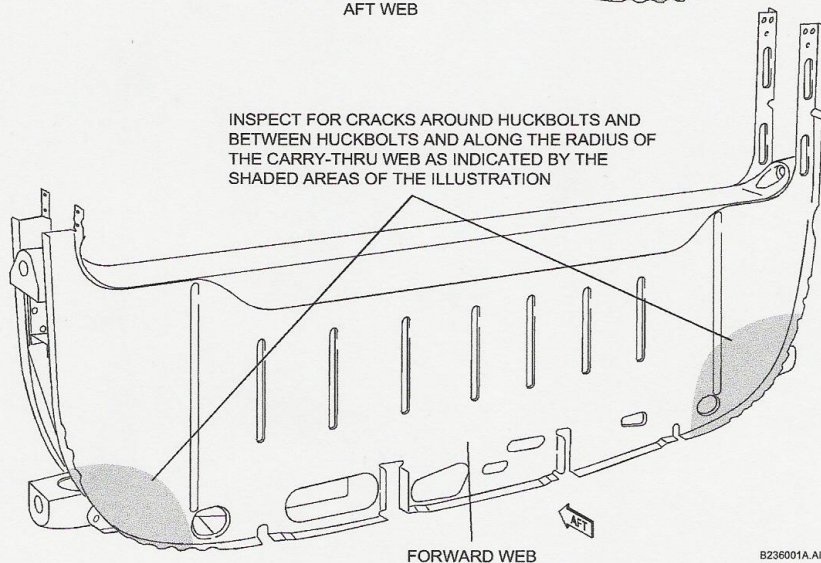
B236001A.AI

INSPECT FOR CRACKS AROUND HUCKBOLTS AND BETWEEN HUCKBOLTS AND ALONG THE RADIUS OF THE CARRY-THRU WEB AS INDICATED BY THE SHADED AREAS OF THE ILLUSTRATION

Inspection for Cracks in the Wing Forward Spar Carry-Thru Structure Forward and Aft Frames

- Initial inspection @1500TT
- No cracks: every 500 hours thereafter

If cracks in web near/through huck bolts:

- <1.0 inch:
  - reinspect at annual/every 200 hours
- >1.0 inch or connecting two huck bolt holes or cracks on forward and aft side of web on same side of aircraft:
  - Install Beech doubler repair kit

*Cannot stop drill through web: damage beneath*

## Cracks in the flange radius:

- <2.25 inch:
  - Stop drill crack
  - Reinspect every 200 hours thereafter
- 2.25 – 4.0 inch
  - Install Beech doubler repair kit within 100 hours
- >4.0 inch
  - Install Beech doubler repair kit prior to flight

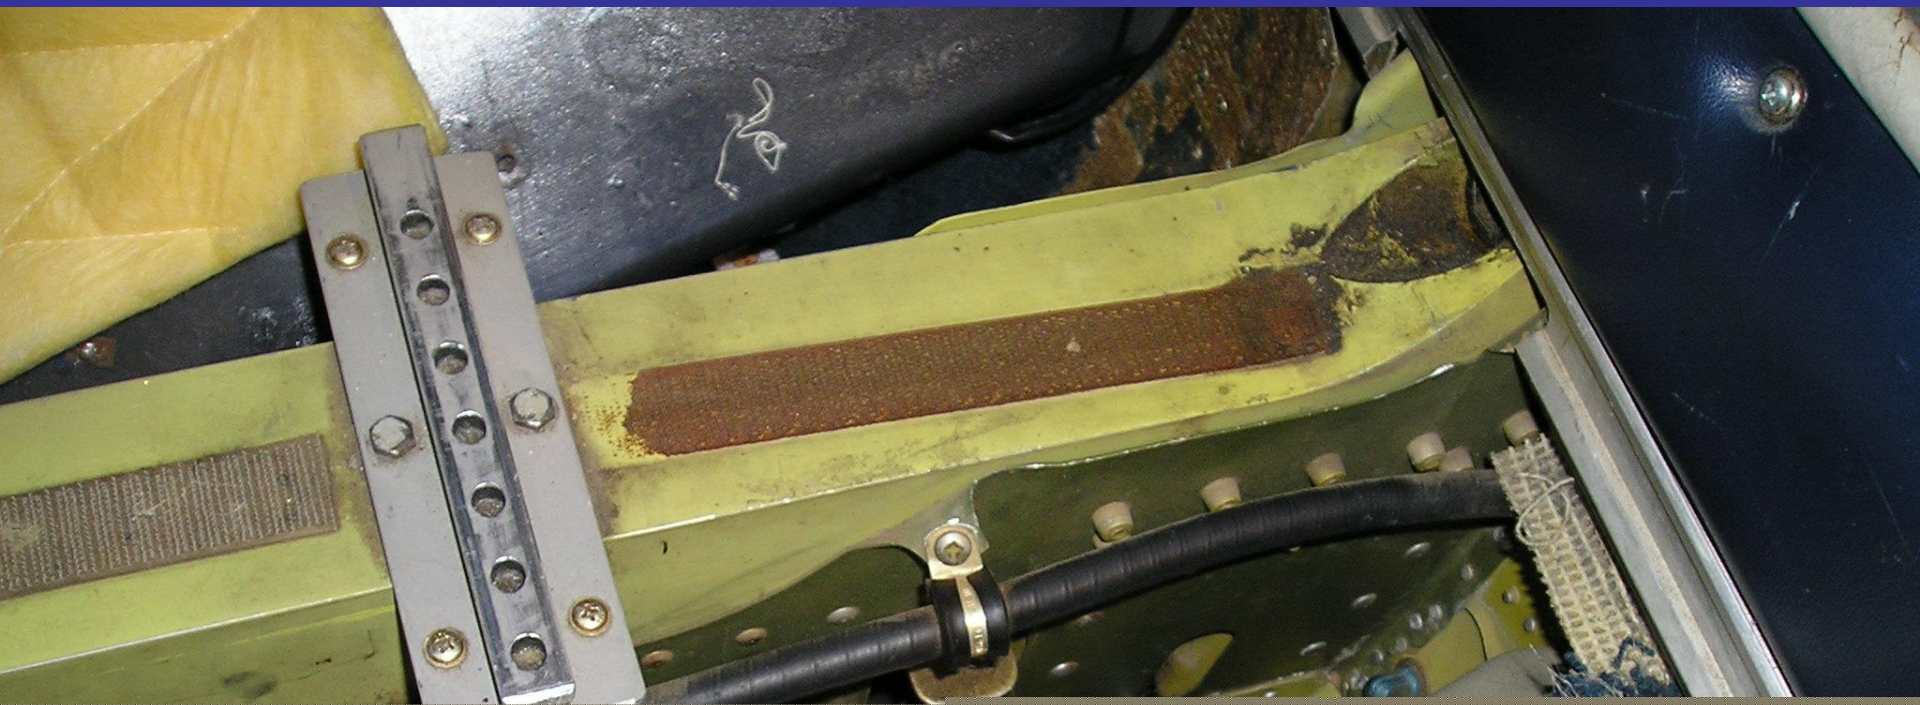
# Doubler Installation

- Kit repairs cracks locally but does “very little for the fore and aft loads that are the cause of cracks seen to date.”
- Kit increases stiffness and therefore increases web stresses
- Kit in conjunction with “a robust external doubler to the fuselage skin should cause no harm.”

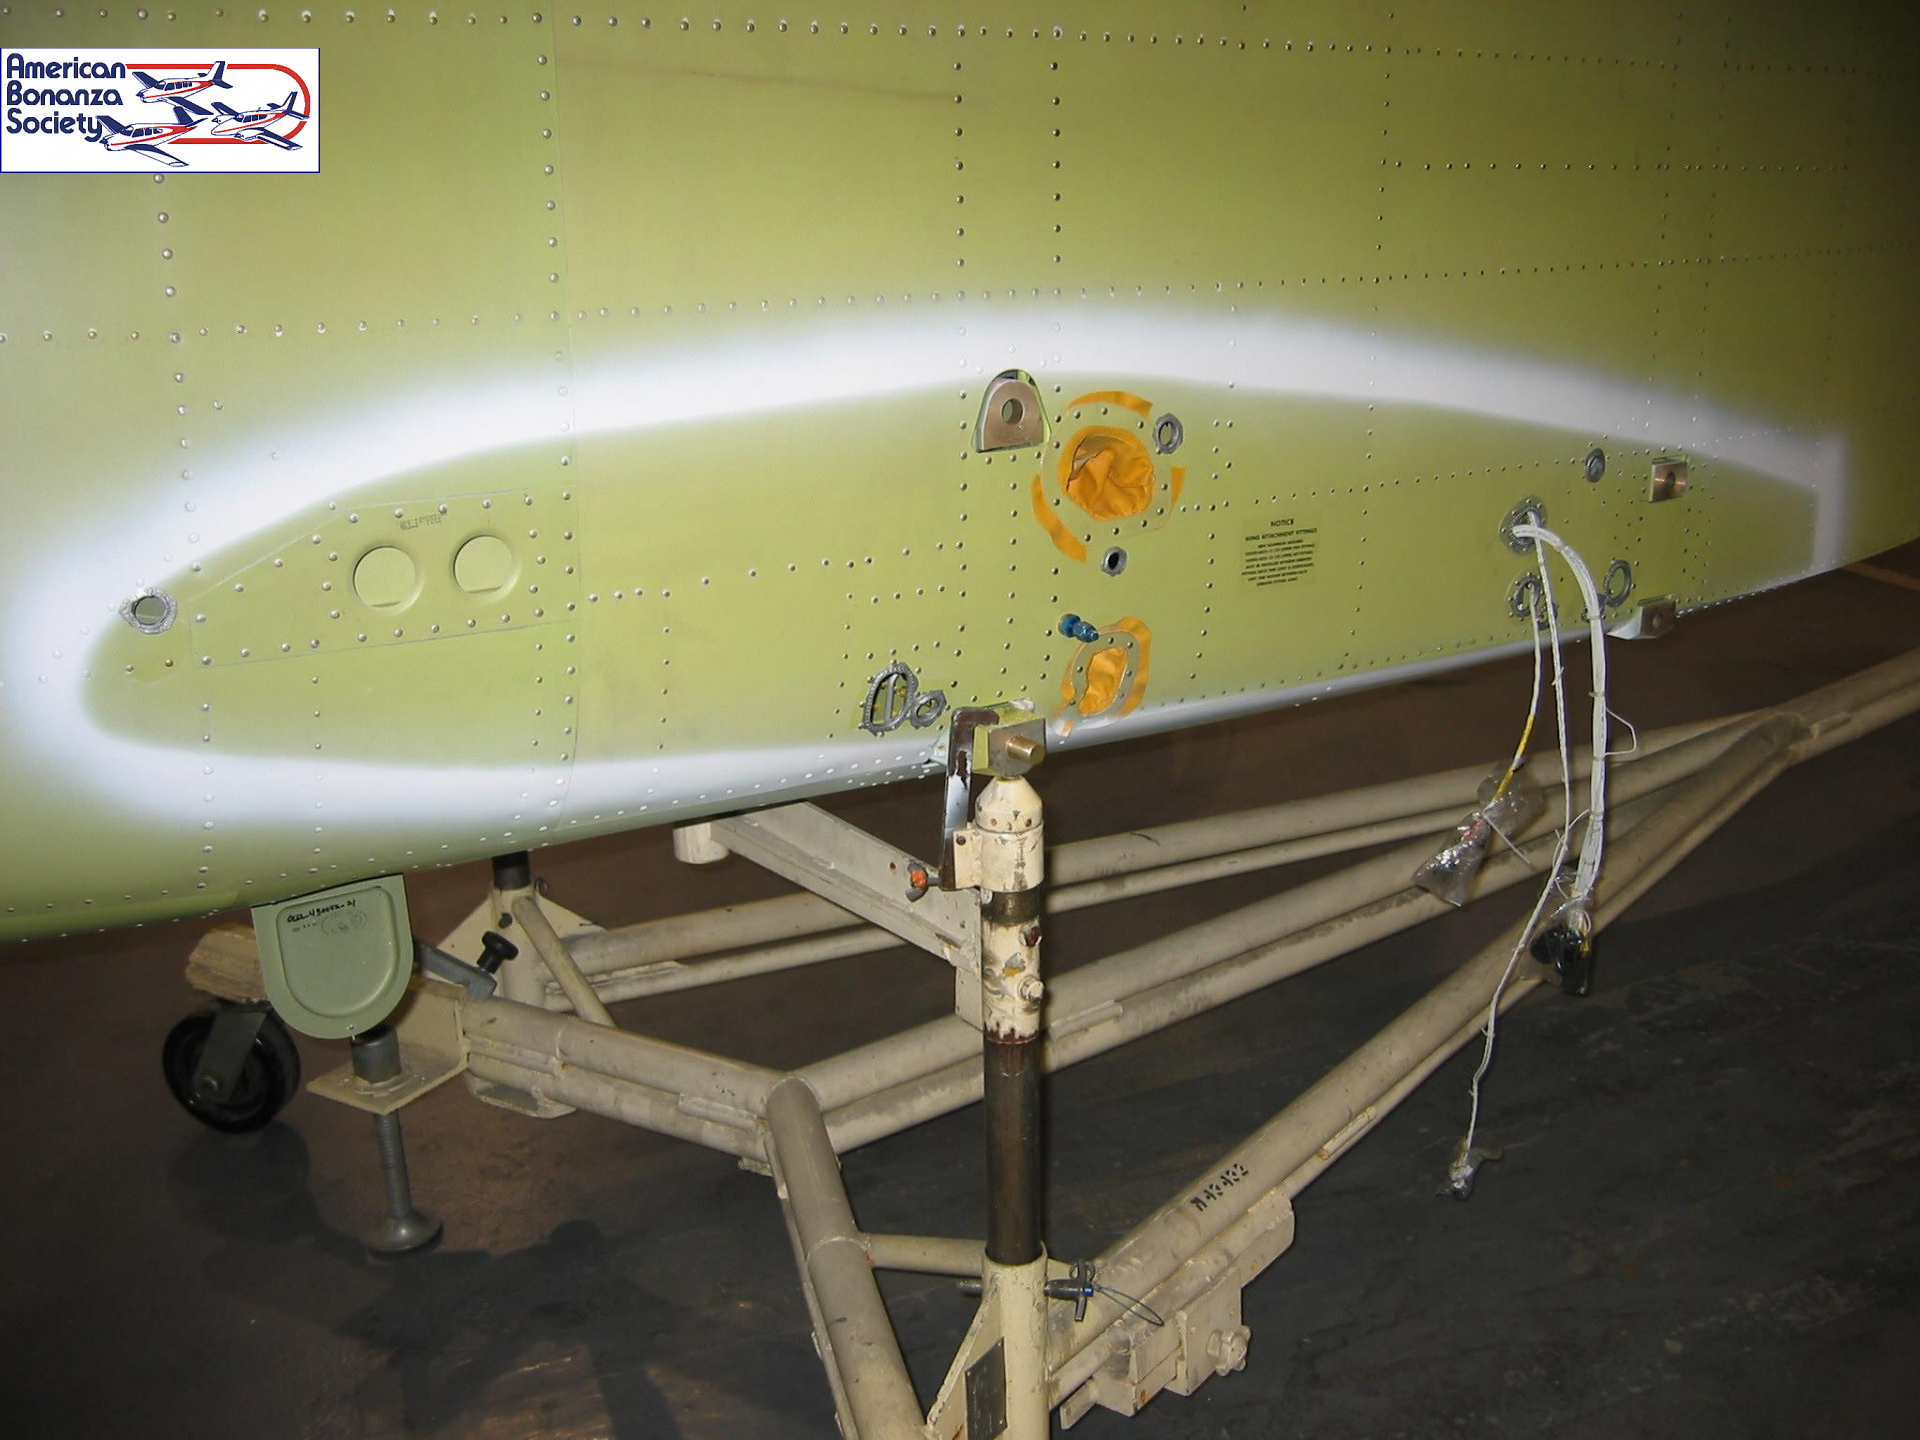
N785JB V35A

- Low-intensity, frequently repeated loads from normal operation
- Primarily driven by nose gear loads during landing and ground handling
- Longitudinal stresses directed around the fuselage skin wing spar cutouts

Cracks

View of Right hand, forward face

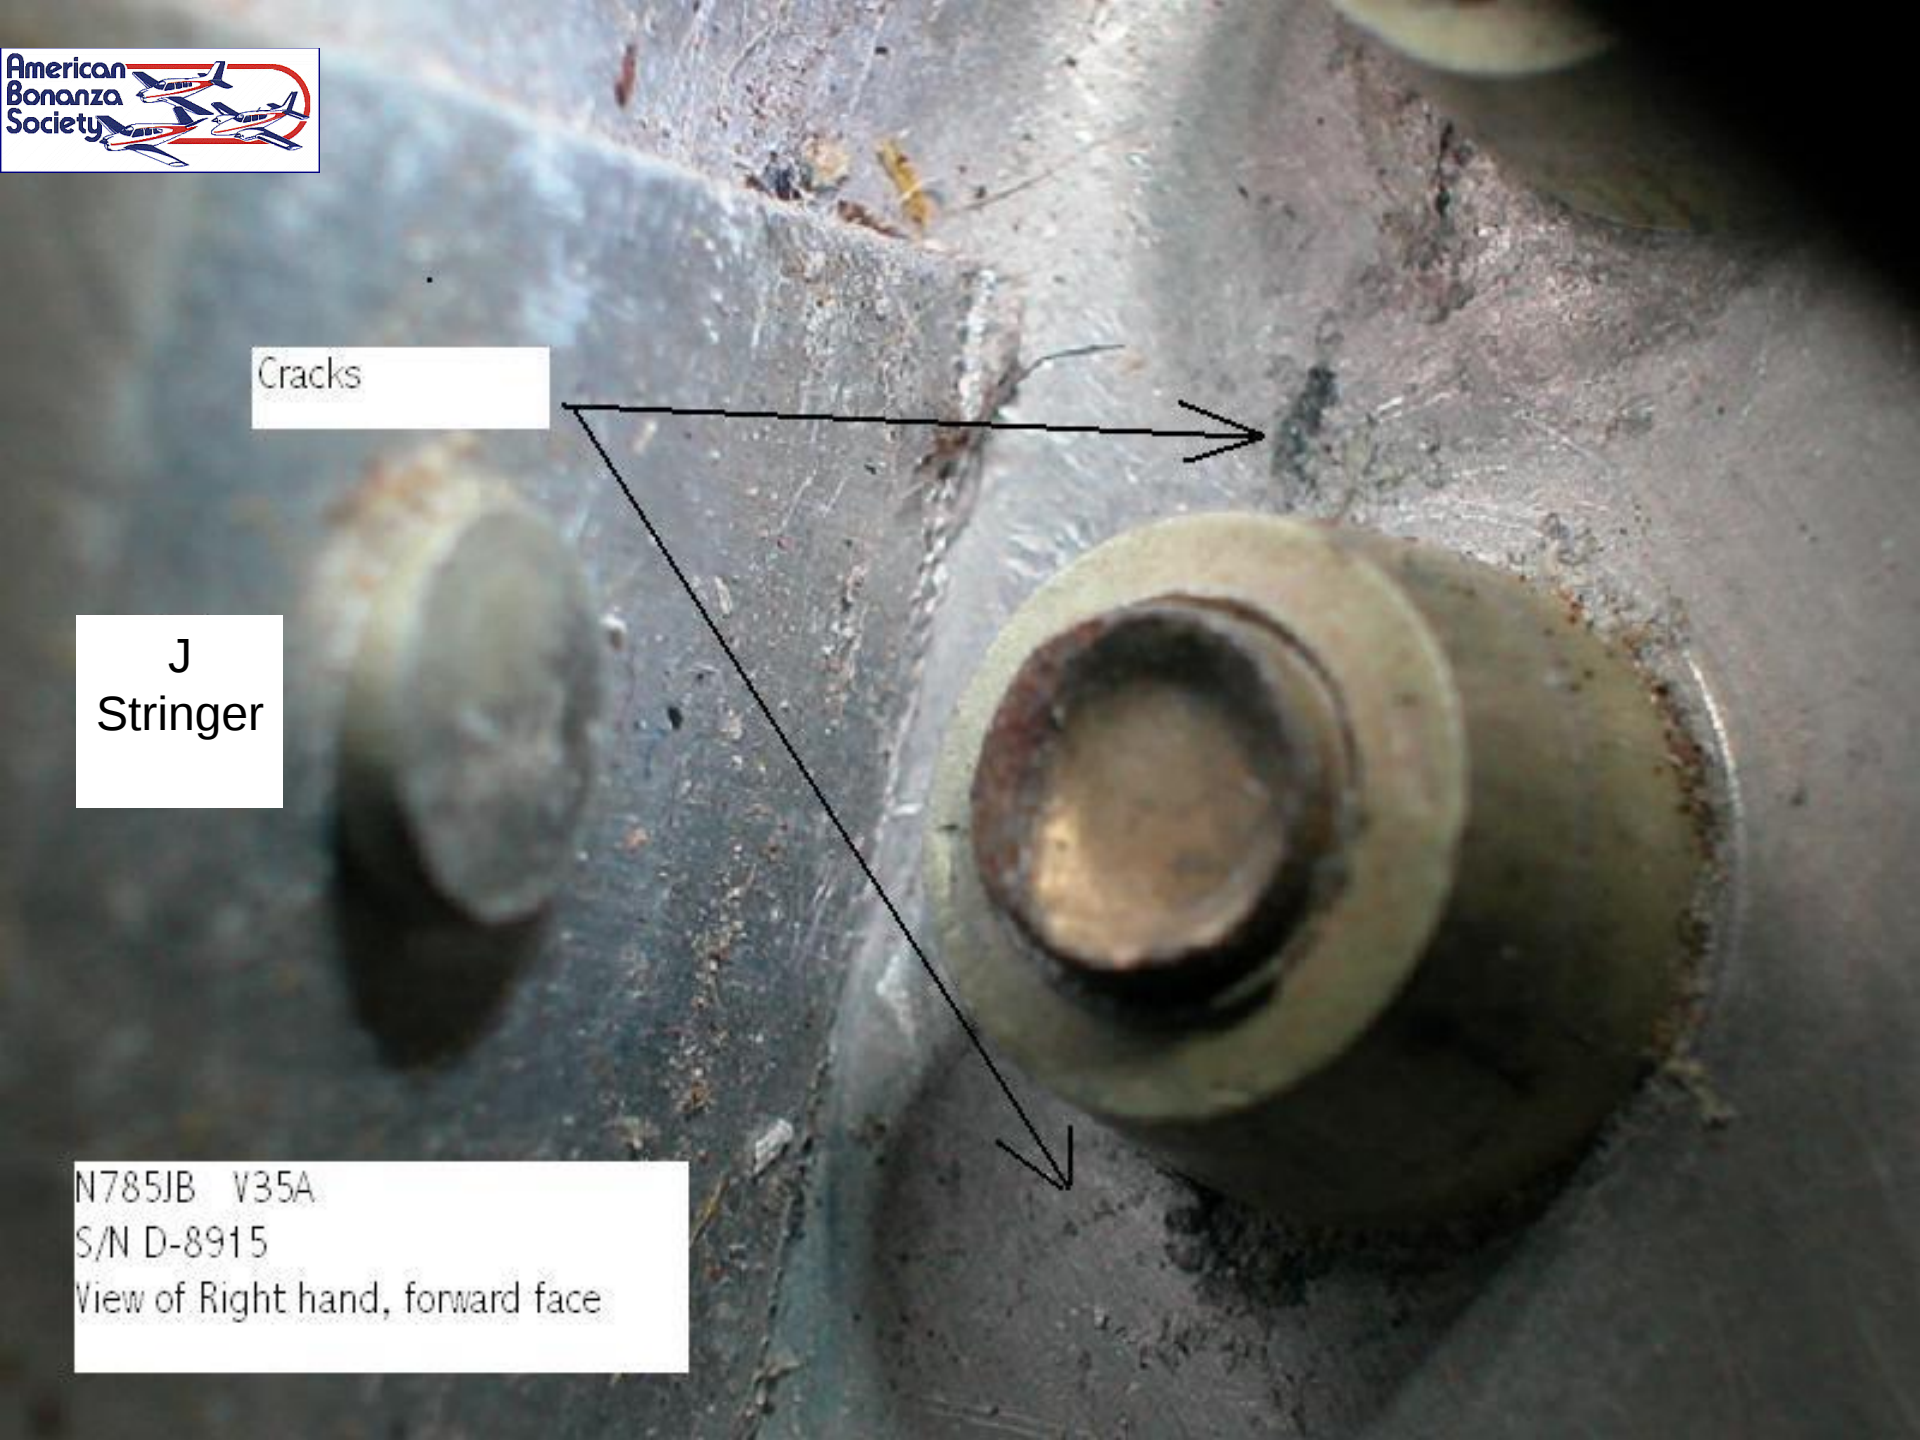
Longitudinal flexing

- Initial Huck bolt-area cracks allow flexing that develops to bend radius cracks
- The engineers “doubt the validity” of Wilson’s work and “cannot agree with his conclusion that the cracking will not potentially cause safety problems.”
