# Safety Communique

January, 2011

**SUBJECT:** FLAP ACTUATOR ATTACHMENT BRACKET AND NOSE RIB ASSEMBLY

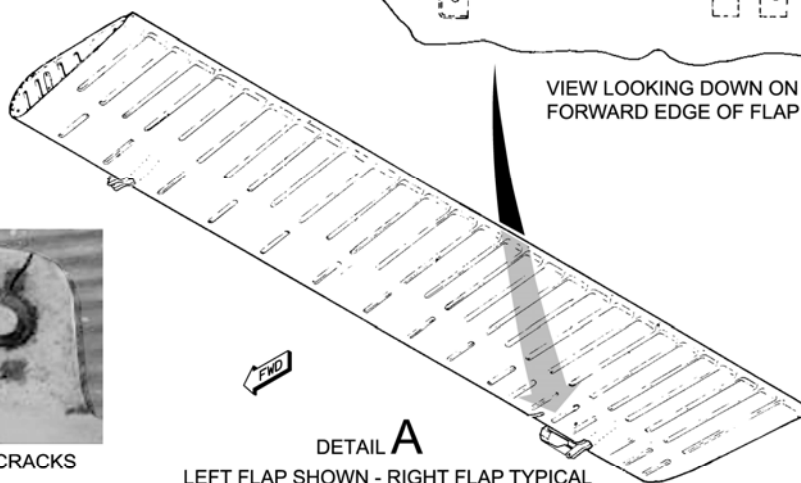
DETAIL A  
LEFT FLAP SHOWN - RIGHT FLAP TYPICAL

A review of the ten reports identified affected airplanes as having between 4,000 and 6,500 flight hours (total time in service). Most of the affected parts were right flap parts, located adjacent to the cabin entrance. However, cracks have been found on the same nose rib on the left side nose rib assembly.

AREA OF POTENTIAL CRACKS  
DETAIL B

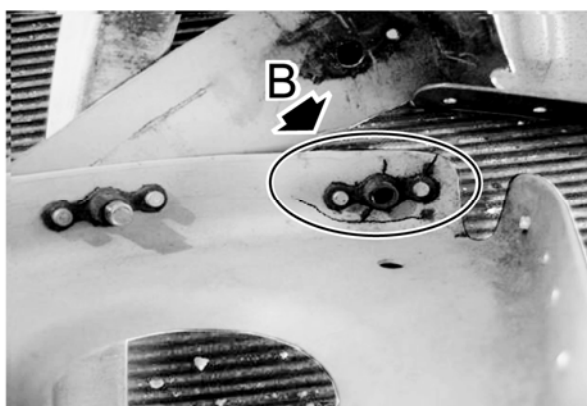
HBC has received ten reports from the field of crack damage on the part number (P/N) 35-165050-84 nose rib assembly for the flap actuator attachment bracket. Refer to Figure 1. In October 2007, a pilot reported a split flap condition during flap extension to a 14 CFR Part 145 repair station. The repair station found the flap actuator mounting plate cracked. The mounting plate is secured to the flap by three screws, which are attached to the nose rib assembly by nutplates. Further inspection of the flap revealed cracks in this nose rib. Since the repair station regularly performed inspections on several models of HBC airplanes, they began paying particular attention during inspections to these areas and submitted six service difficulty reports on Model 33, 35, 36, and 95 airplanes. In January 2008, Advisory Circular 43-16A was issued detailing these reports. The flap actuator mounting is of similar design on all of the reported airplanes. Through May 2010, this repair station addressed four additional service difficulty reports for cracks found on the same part number nose rib assembly.

Flap leading edge nose rib and/or the flap actuator mounting bracket cracking has the potential to cause the part to become disconnected, and could result in a split flap condition.

EXAMPLE OF CRACK IN P/N 35-165050-84 NOSE RIB

HBC reminds maintenance facilities of the importance of adhering to existing inspection and maintenance procedures in the applicable airplane series Maintenance Manual or Shop Manual and specified spare parts in the applicable Illustrated Parts Catalog when replacing components during routine maintenance.

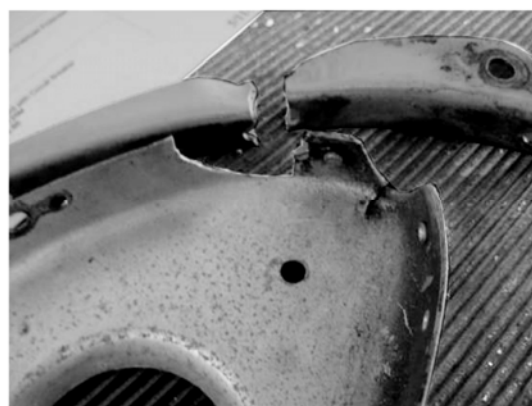
EXAMPLE OF TORN FLANGE IN P/N 35-165050-84  
WITH NUTPLATE MISSING
