# Raytheon Aircraft

## MANDATORY SERVICE BULLETIN

No. 2190  
ATA Code 52-10

**SUBJECT:** DOORS - CABIN DOOR LATCHING WARNING PLACARD AND CABIN DOOR ADJUSTMENT INSTRUCTIONS

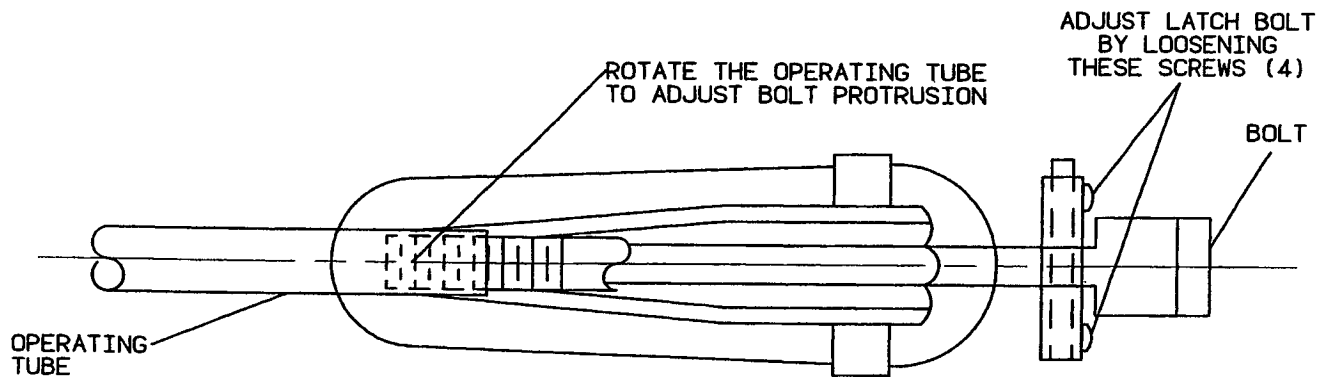
VIEW C  
INSIDE DOOR LOOKING OUTBOARD

c. **AFT LATCH BOLT** - Check to ensure that the aft latch bolt provides a precatch and protrudes into the socket on the aft door frame as far as possible without bottoming out. If adjustment is required, proceed as follows, referring to Figure 1, View C.

1) Disconnect the operating tube at the inside door handle.

2) Disconnect the lower aft latch pin mechanism from the operating tube (if applicable).

3) Rotate the tube to allow the bolt to protrude the proper distance.

4) Reconnect the lower aft latch pin mechanism (if applicable) to the operating tube. Reconnect the operating tube to the inside door handle.

The aft latch bolt can be adjusted inboard or outboard by loosening the four retaining screws on the aft side of the door and moving the bolt inboard or outboard as necessary, and then tightening the four screws.
