# Raytheon Aircraft

## MANDATORY SERVICE BULLETIN

No. 2242, Rev. I  
ATA Code 27-30  
Recurring Inspection

**SUBJECT:** FLIGHT CONTROLS - INSPECTION AND/OR REPLACEMENT OF MAGNESIUM ELEVATOR CONTROL FITTINGS

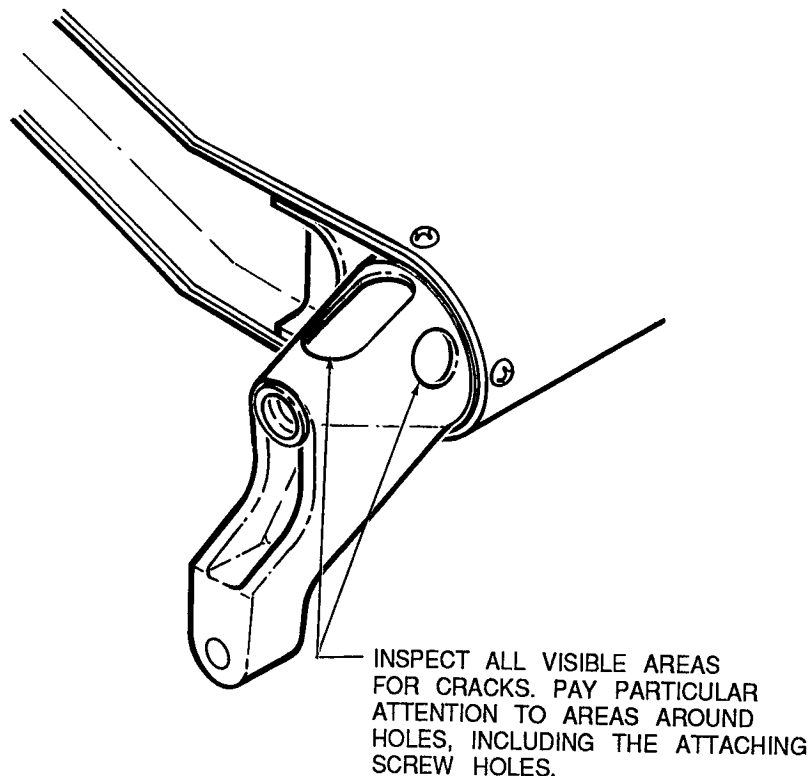
1. Refer to Figure 1 and inspect both elevator control fittings as shown.

2. Ensure correct freedom of movement of both elevator control fittings.
