## SERVICE BULLETIN

### Beechcraft

**TITLE: FLIGHT CONTROLS- RUDDER CABLE PULLEY BRACKET INSPECTION/REPAIR**

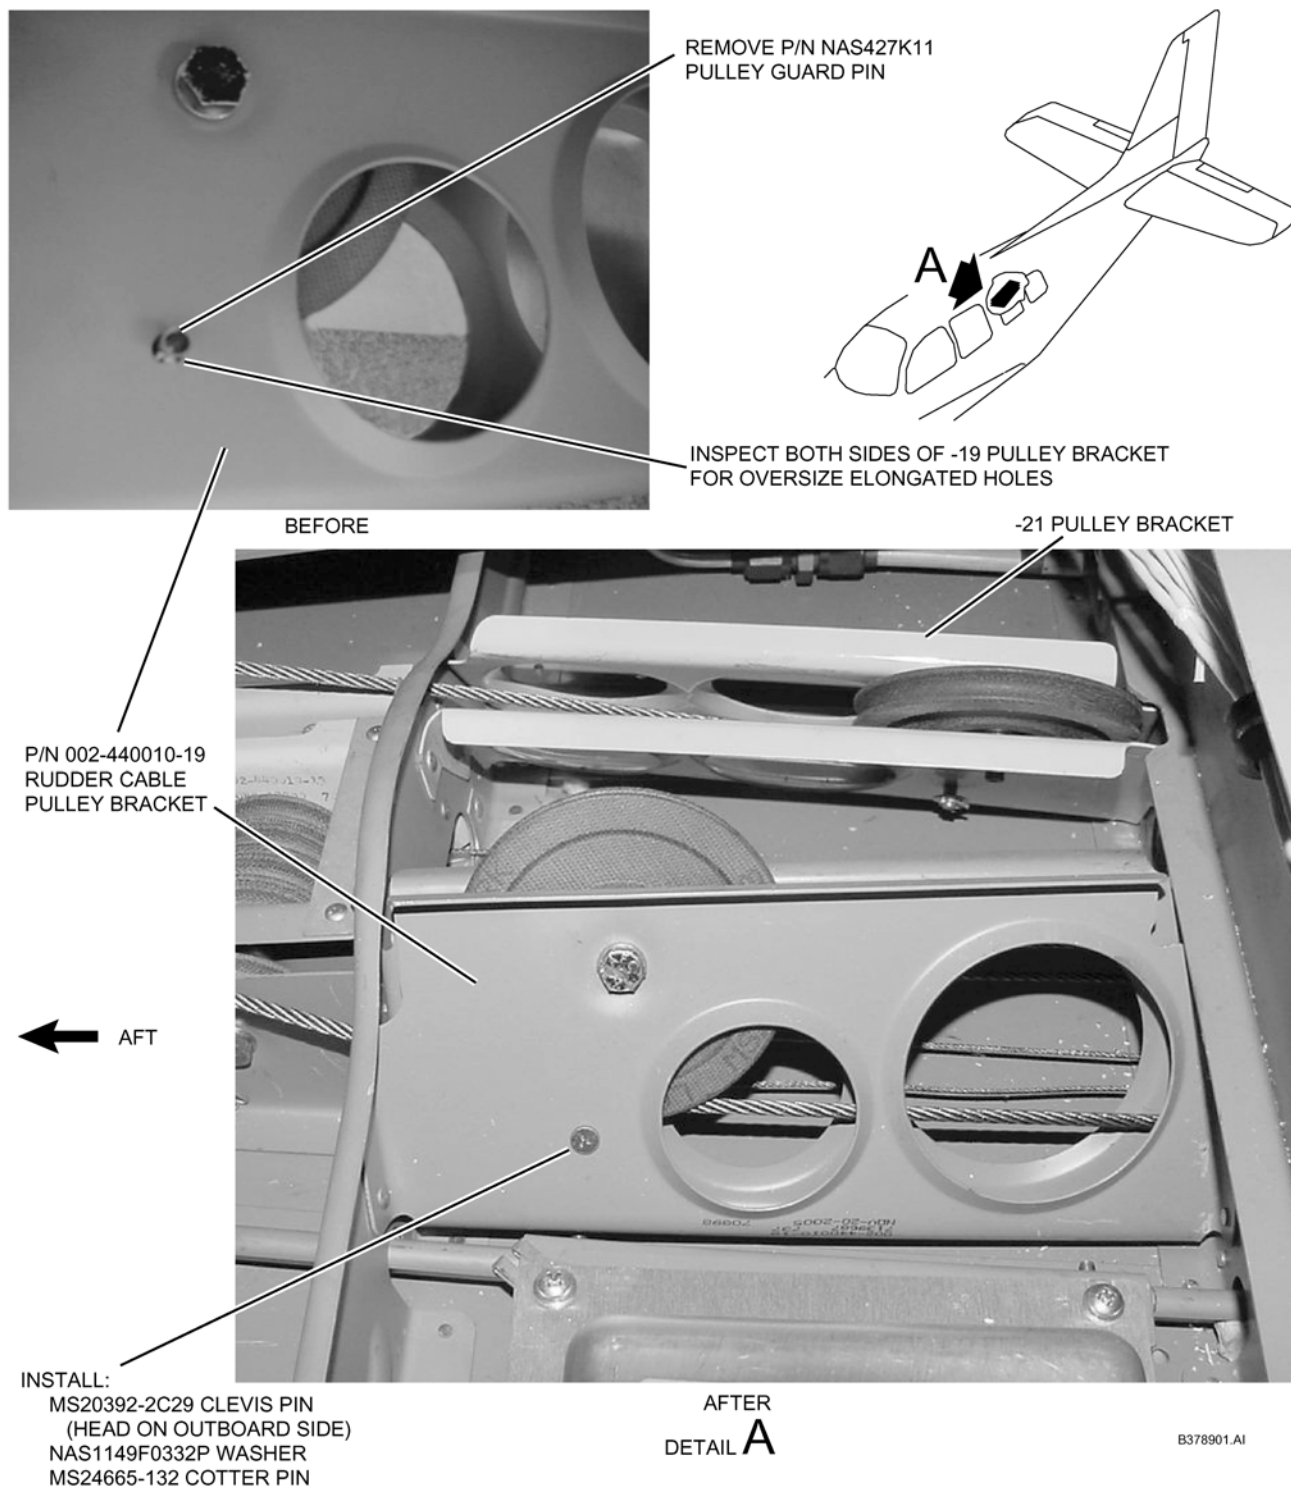
**Figure 1**

- (3) Between F.S. 151.00 and F.S. 179.00, locate the area where the suspect pulley guard pin holes are in the P/N 002-440010-19 rudder cable pulley bracket. The P/N 002-440010-19 rudder cable pulley bracket is canted inboard. Refer to Figure 1.

- (4) Inspect the existing holes in both sides of P/N 002-440010-19 pulley bracket for the P/N NAS427K11 pulley guard pin for an elongated hole or misdrilling condition. If the holes do not exhibit any evidence of elongation or misdrilling, proceed to step (6). If the holes show evidence of elongation/misdrilling, proceed to step (5).

**Installation of the Pulley Guard Pin in the Rudder Cable Pulley Bracket**

- (5) Replace the existing P/N NAS427K11 pulley guard pin with an MS20392-2C29 clevis pin, NAS1149F0332P washer and MS24665-132 cotter pin. Refer to Figure 1.
