## SERVICE BULLETIN

**TITLE: LANDING GEAR - INSTALLATION OF UPLOCK STOP BRACKET BOLTS**

It is recommended that a note "See Service Bulletin No. 32-3087" be made in the following:

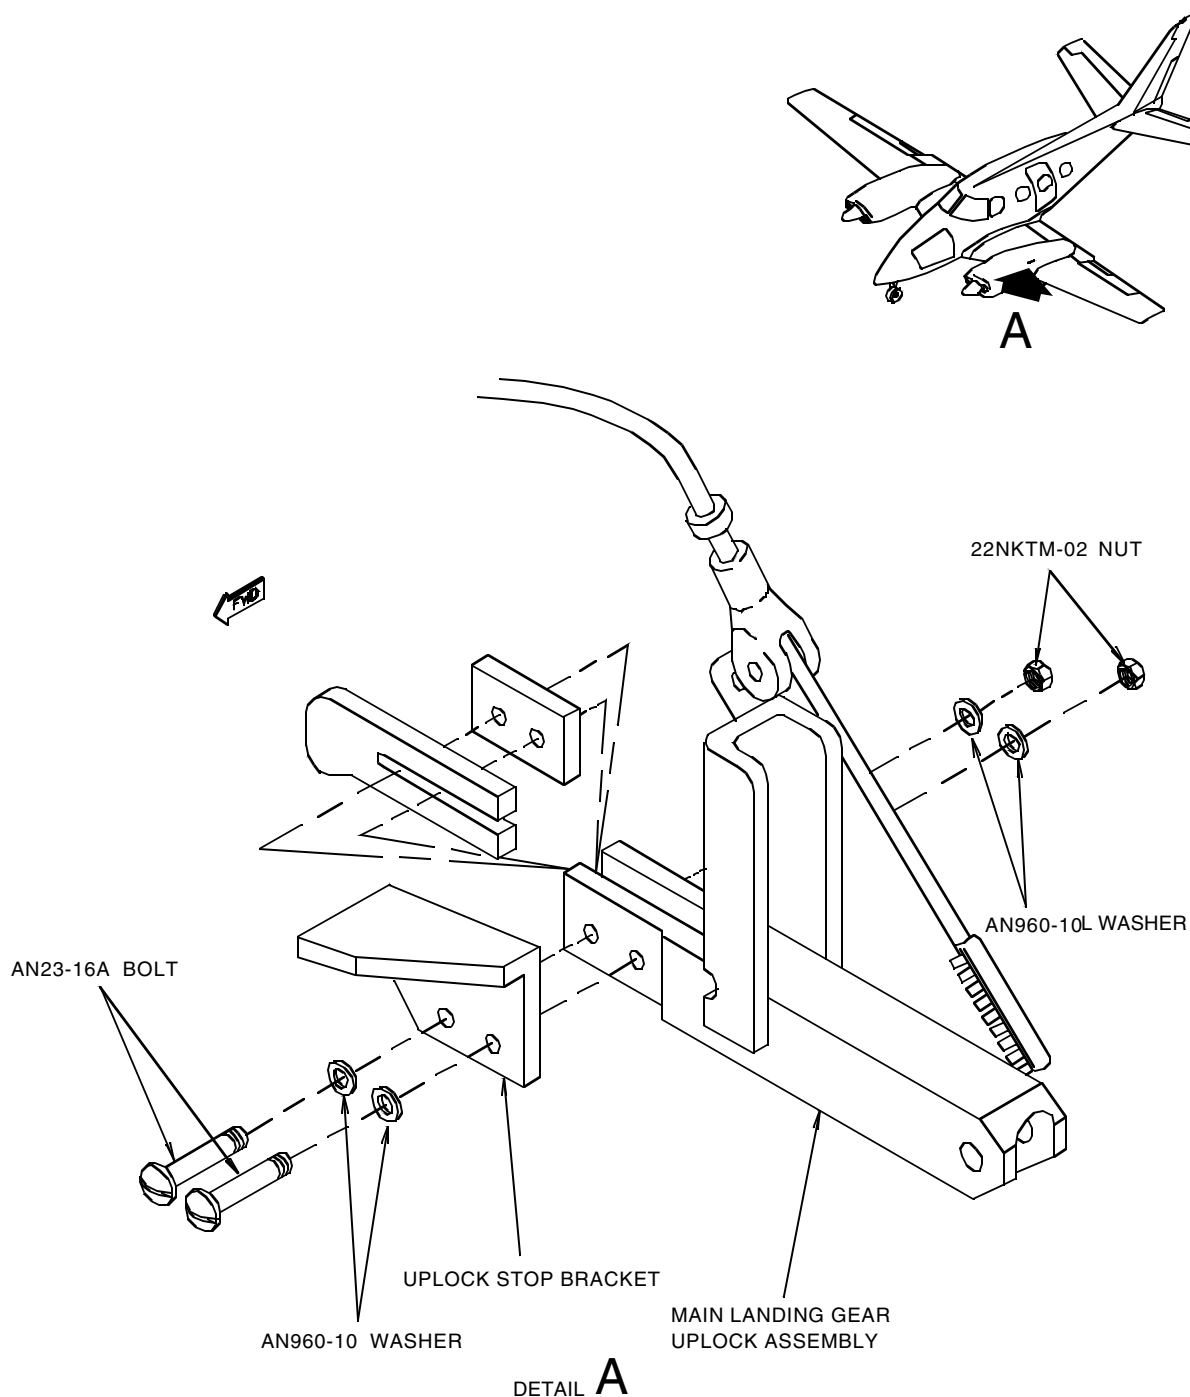
**Main Landing Gear Uplock Stop Bracket Installation**  
**Figure 1**

This Service Bulletin is being issued to clarify proper uplock stop bracket bolt type and installation when a new design lower lift leg (with a larger uplock stop contact area) is installed on any of the affected aircraft which have either been manufactured with, or modified to include, uplock stop brackets. If the main landing gear lower lift leg comes in contact with the uplock stop bracket bolts while cycling the landing gear, the retract rod can be damaged preventing full extension of the landing gear. It is also possible that the lower lift leg may hang on the uplock stop bracket bolts, if they are incorrectly installed, which could prevent the main gear from extending.

- (1) Remove all power from the airplane and disconnect the battery.
- (2) Refer to Chapter 7 of the appropriate Maintenance Manual and place the airplane on jacks.
- (3) Refer to Figure 1 and accomplish the following:
  - (a) Observe the bolts that secure the uplock stop bracket to the uplock assembly. They should be type AN23-16A (pan heads with screwdriver slots as opposed to hex heads) and should be installed with the threaded ends facing aft (the nuts should be on the aft side of the uplock assembly).

- (b) If the uplock stop bracket bolts ARE NOT the correct type, they must be replaced.
  - (c) If the uplock stop bracket bolts ARE the correct type but installed facing the wrong direction, they and the accompanying hardware must be removed, thoroughly inspected for damage, and re-installed as necessary.
  - (d) Repair damaged finish if required as directed in Chapter 20-00 of the applicable Maintenance Manual using materials listed in Parts Schedule II.
- (4) Reconnect the airplane battery, remove warning notices and restore power.
