SERVICE BULLETIN

TITLE: NAVIGATION - GARMIN G1000 SYSTEM UPGRADES INCLUDING TERRAIN AWARENESS AND WARNING SYSTEM (TAWS-B) FUNCTION PER STC SA01725SE

SYNOPSIS OF CHANGE

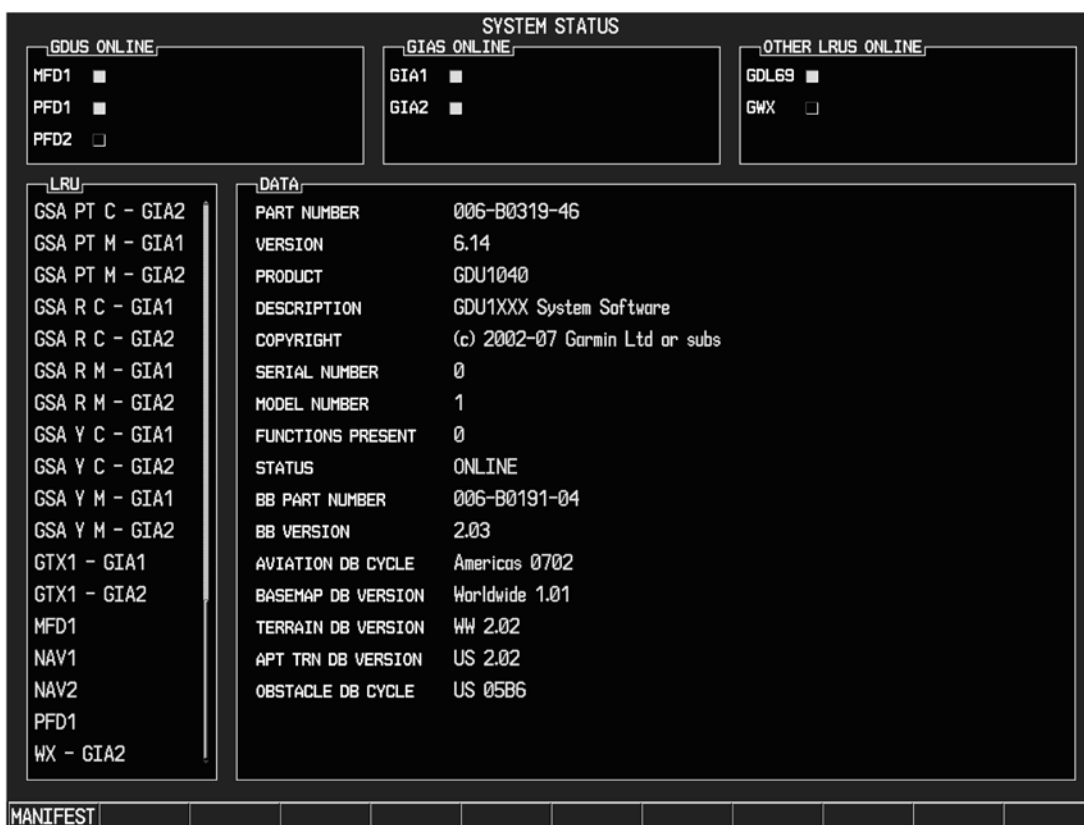
System Status Page
Figure 2

- (a) Go to the System Status page using the FMS knob. Activate the cursor and toggle to the LRU window. Refer to Figure 2.
- (b) Highlight the following items in the LRU window, and verify that the software part number and version matches the Required LRUs and Software in Table 1.

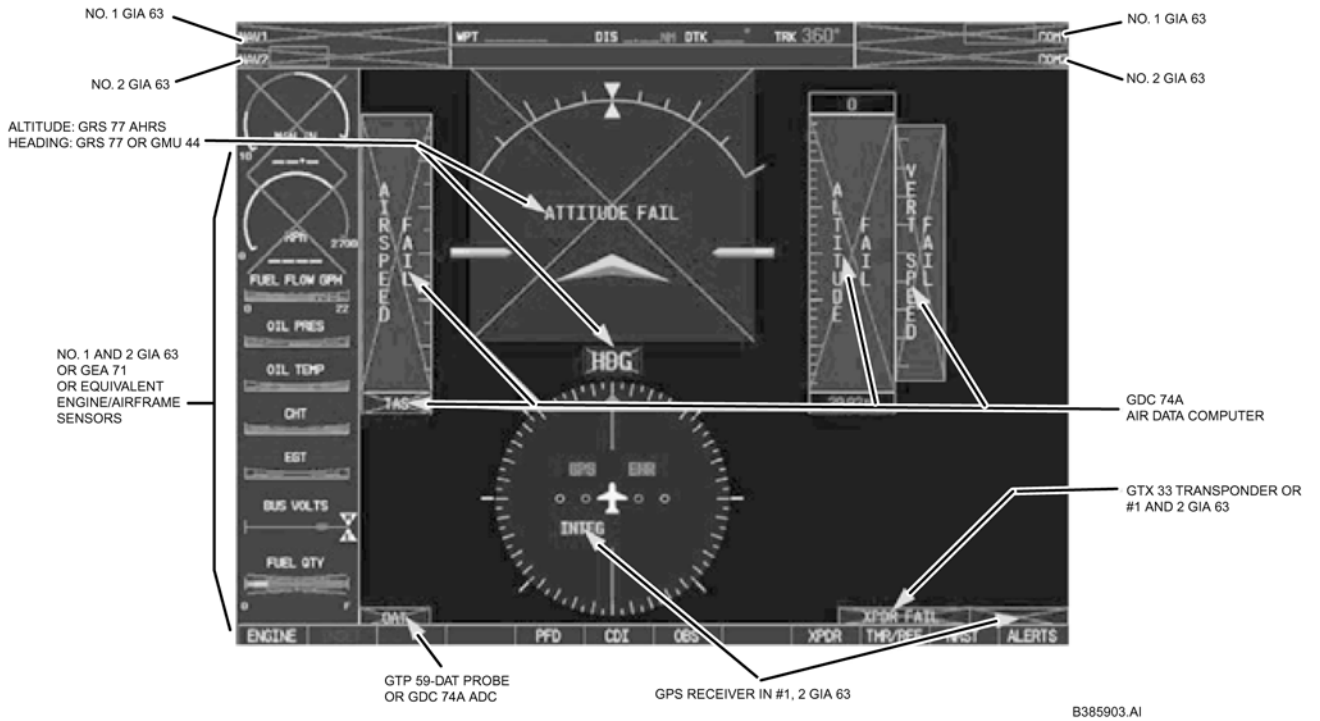
Invalid Data Fields (Large Red Xs)
Figure 3

In the normal operating mode, data fields that are invalid have large red Xs through them (refer to Figure 3). A valid field does not display a red X. Allow the displays to initialize for approximately one minute. The GDC 74A, GMU 44 and the GRS 77 LRUs require a longer initialization period than do the other LRUs. During normal operation, this causes the respective fields of these LRUs to be invalid during the first few minutes of PFD power-up.
