## SERVICE BULLETIN

**TITLE: FUSELAGE - WING FORWARD SPAR CARRY-THRU STRUCTURE INSPECTION AND/OR REINFORCEMENT**

Issued: August, 1989  
Revised: June, 2004

**SB 53-2269, REV. 2**

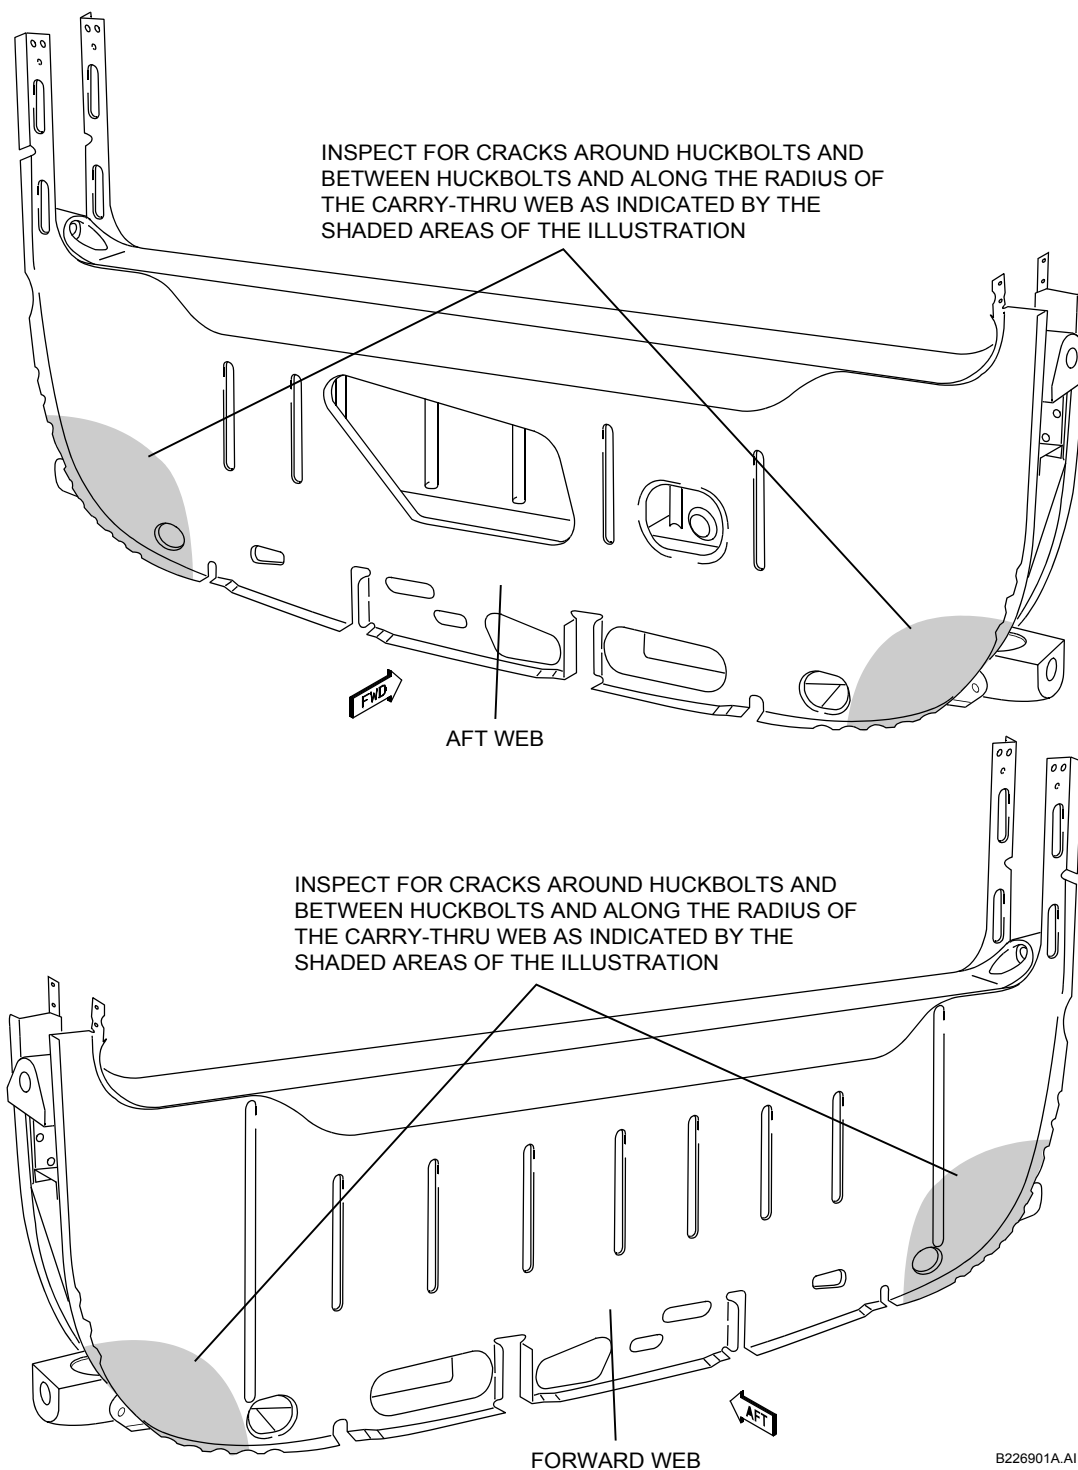
**Figure 1**

This Service Bulletin is being issued to provide inspection and repair information relating to forward wing spar carry-thru structure forward and aft frames. Reports of frame (web) cracking have been received on in-service airplanes. If these cracks are detected at any time, the repairs described in this Service Bulletin should be applied.

- (2) Remove the pilot's and copilot's seats and the carry-thru cover to obtain access to the front spar carry-thru structure.
- (3) Thoroughly clean the forward and aft frames (webs) of the front spar carry-thru structure in the shaded areas shown in Figure 1.
- (4) Perform a visual inspection of the area cleaned in step 3 for evidence of cracks.
- (5) Perform a dye penetrant inspection using visible dyes, of the area cleaned in step 3 for evidence of cracks.

Cracks found in the shaded areas of Figure 1 that have not been modified by a doubler must be repaired as indicated in this Service Bulletin on an individual basis.

The extent of repair is limited to cracking in the radius of the web flange and cracks in the web flat areas at the fasteners of the lower front spar cap.

**Inspection for Cracks in the Wing Forward Spar Carry-Thru Structure Forward and Aft Frames**

- (i) A crack up to 4.0 inches in length shall be stop drilled at the ends using a #30 drill bit. The area is to be repaired per the applicable P/N 58-4008 Kit(s) within the next 100 flight hours, 12 calendar months or the next scheduled inspection whichever occurs first.

- (ii) A crack exceeding 4.0 inches in length shall be repaired PRIOR TO FURTHER FLIGHT per the applicable P/N 58-4008 Kit(s).

- (i) A crack emanating from one fastener in two directions is considered to be one crack. **Do not stop drill, due to the possibility of damaging structure behind web face.**
- (ii) Any crack shall be repaired per the applicable P/N 58-4008 Kit(s), within the next 25 flight hours, 12 calendar months or the next scheduled inspection whichever occurs first.
- (iii) A crack passing through two fasteners and extending beyond for more than 0.5 inch on either end shall be repaired PRIOR TO FURTHER FLIGHT, per the applicable P/N 58-4008 Kit(s).
- (iv) A crack passing through two fasteners and extending beyond for less than 0.5 inch on both ends shall be repaired per the applicable P/N 58-4008 Kit(s), within the next 25 flight hours, 12 calendar months or the next scheduled inspection whichever occurs first.

(c) If cracks are found in both the forward and aft frames on the same side of the airplane, in either the web face and/or the bend radius, and any of the cracks are more than 1.0 inch long, a repair shall be made PRIOR TO FURTHER FLIGHT.

(d) If cracks are found in both the forward and aft frames on the same side of the airplane, in either the web face and/or the bend radius, and all of the cracks are less than 1.0 inch long, a repair shall be made per the applicable P/N 58-4008 Kit(s) within the next 25 flight hours, 12 calendar months or the next scheduled inspection whichever occurs first.

(7) Repair all cracks per the applicable P/N 58-4008 Kit(s).
