## SERVICE BULLETIN

**TITLE: FUSELAGE - INSPECTION/INSTALLATION OF RH FUSELAGE MISSING RIVETS**

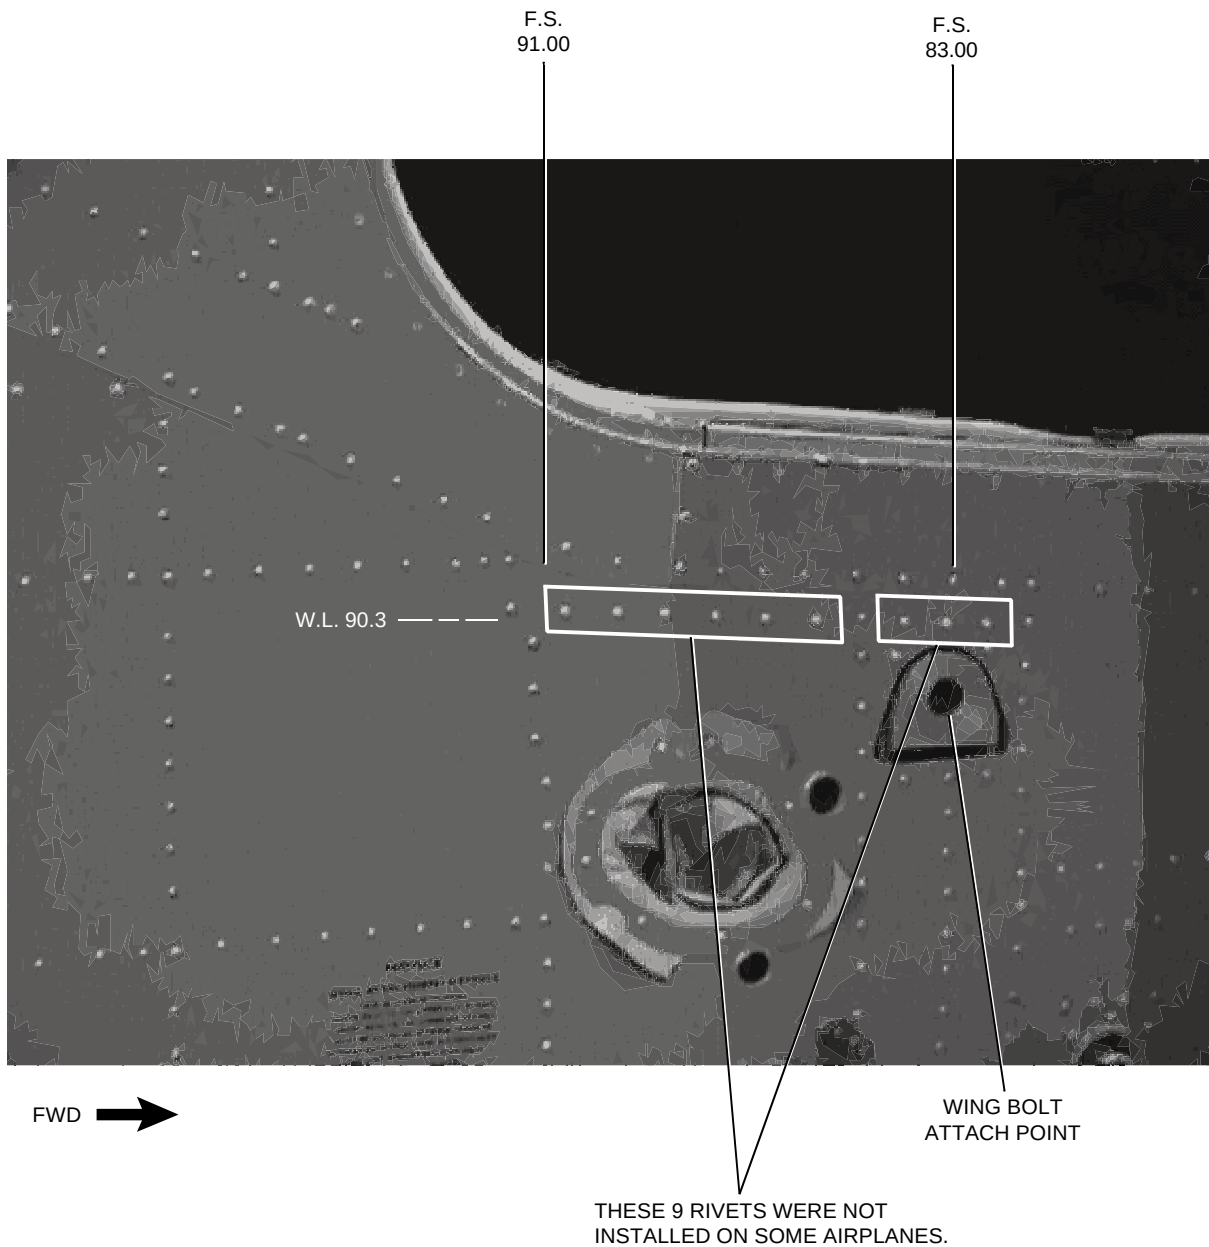
Inspection/Installation of Missing Rivets in RH Fuselage  
Figure 1

This Service Bulletin is being issued to inspect for and install missing rivets in the lower right hand fuselage panel assembly in the area above the right wing and below the cabin door threshold. These rivets must be present for the fuselage to carry ultimate load.

- (1) Refer to Figure 1 and inspect for rivets between F.S. 83.00 and F.S. 91.00 at W.L. 90.3. Universal (round) head or flush head blind rivets may have been installed along this rivet line. If rivets are installed in the noted locations, no further action is necessary. If rivets are not present, proceed to step 2.
- (2) Remove all power from the airplane and disconnect the battery. Display warning notices prohibiting reconnection of airplane electrical power.
- (3) Open cabin or passenger door to gain access to airplane interior. Refer to airplane Maintenance Manual.
- (4) Remove passenger seats, as required, to gain access to the RH Side Panel. Refer to airplane Maintenance Manual.
- (5) Remove RH Side Panel.
- (6) Remove and retain interior insulation from areas above the floorboards and between the forward and aft spars, 9.70 inches below W.L. 100.00 (approximately W.L. 90.3).

- (8) Drill pilot holes for missing P/N MS20470AD4-X or equivalent rivets in locations as follows (see Figures 1 and 2):
  - (a) Drill three holes through the skin and P/N 002-430043-19 gusset just above the upper wing bolt attach fitting cutout.
  - (b) Drill six holes through the skin and the edge of the P/N 002-430043-19 gusset just aft of the aft web flange on the front spar.
- (9) Drill 0.125 + 0.0035 inch diameter holes for installation of P/N MS20470AD4-X or equivalent rivets.

- (13) Refer to Figure 1 and Figure 2 and install P/N MS20470AD4-X or equivalent rivets in hole locations drilled in step 9. Dip each rivet shank in epoxy polyamide primer and install wet. Use an appropriate size rivet gun and bucking bar to install rivets.
