# SERVICE BULLETIN

## Beechcraft

**TITLE: STABILIZERS - INSPECTION OF ELEVATOR AND RUDDER HINGES FOR MANUFACTURING DAMAGE**

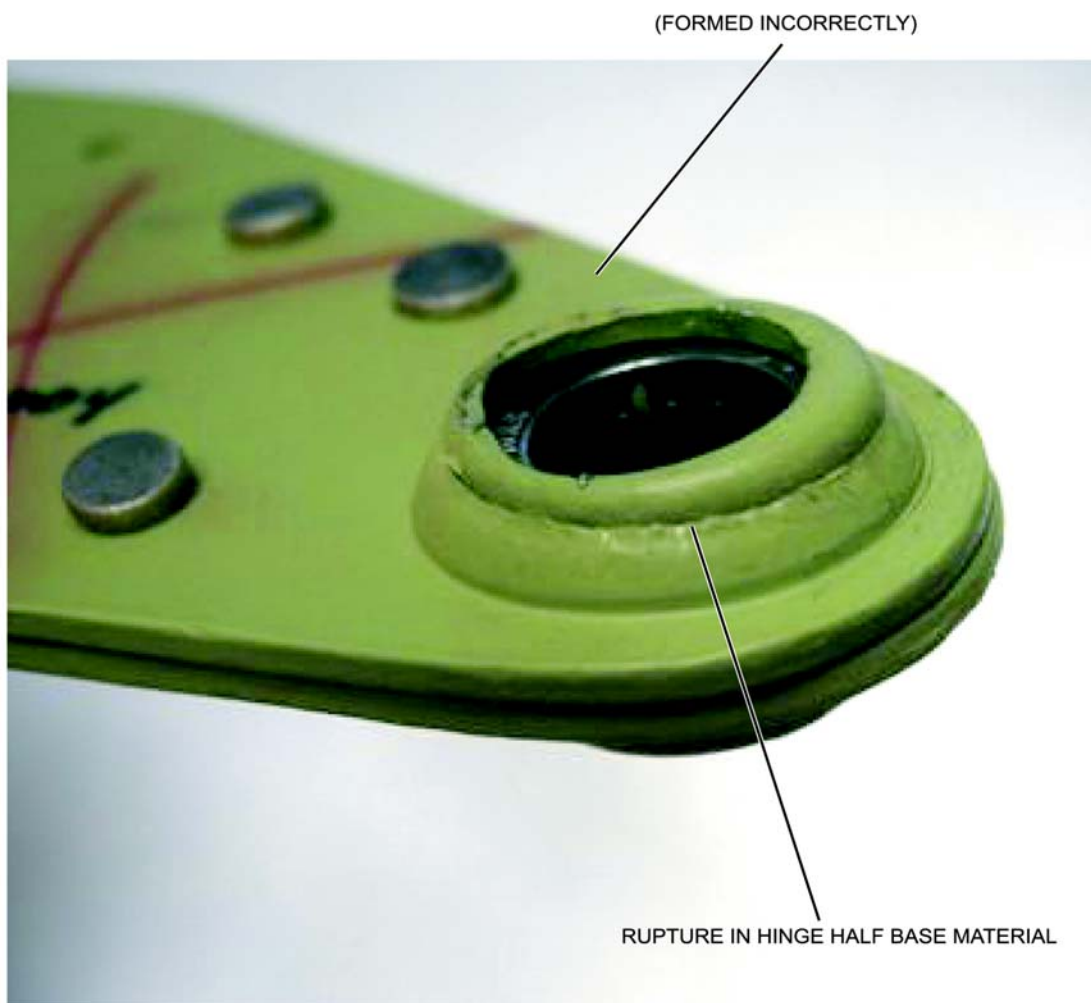
This Service Bulletin is being issued to inspect elevator and rudder hinge brackets in the bearing area for a rupture in the base material. This damage may have occurred during the manufacturing process and may exist on airplanes and spares listed in Section 1. A. **Effectivity**.

Typical Hinge Assembly with Rupture in the Base Material  
Figure 3

If a rupture of the base material in any hinge bracket(s) is found, the affected hinge assembly shall be replaced.

- (a) Remove the flight control surface in accordance with the appropriate chapter of the applicable airplane Maintenance or Shop Manual.
- (b) Drill out rivets securing the affected hinge bracket.
- (c) Remove the discrepant hinge half. Return discrepant hinge half (halves) to the address listed in Section 1. M. **Warranty Credit** to receive warranty credit for removed/replaced parts.
- (d) Dress out the hinge half rivet holes, as required, to ensure a smooth, clean surface is available for installation of rivets for the new hinge halves. Refer to the applicable Illustrated Parts Catalog (IPC) for the required replacement hinge half.

- (e) Install the hinge halves using the same type, length and diameter of rivets, except as indicated in the NOTE above, that were removed from the discrepant hinge half.
- (f) Repeat steps (3)(b) through (3)(e) for each hinge half that requires replacement.
