## SERVICE BULLETIN

### Beechcraft

**TITLE: PROPELLERS - LEFT ENGINE PROPELLER UNFEATHERING ACCUMULATOR OIL TUBE ASSEMBLY CHAFING INSPECTION AND MODIFICATION**

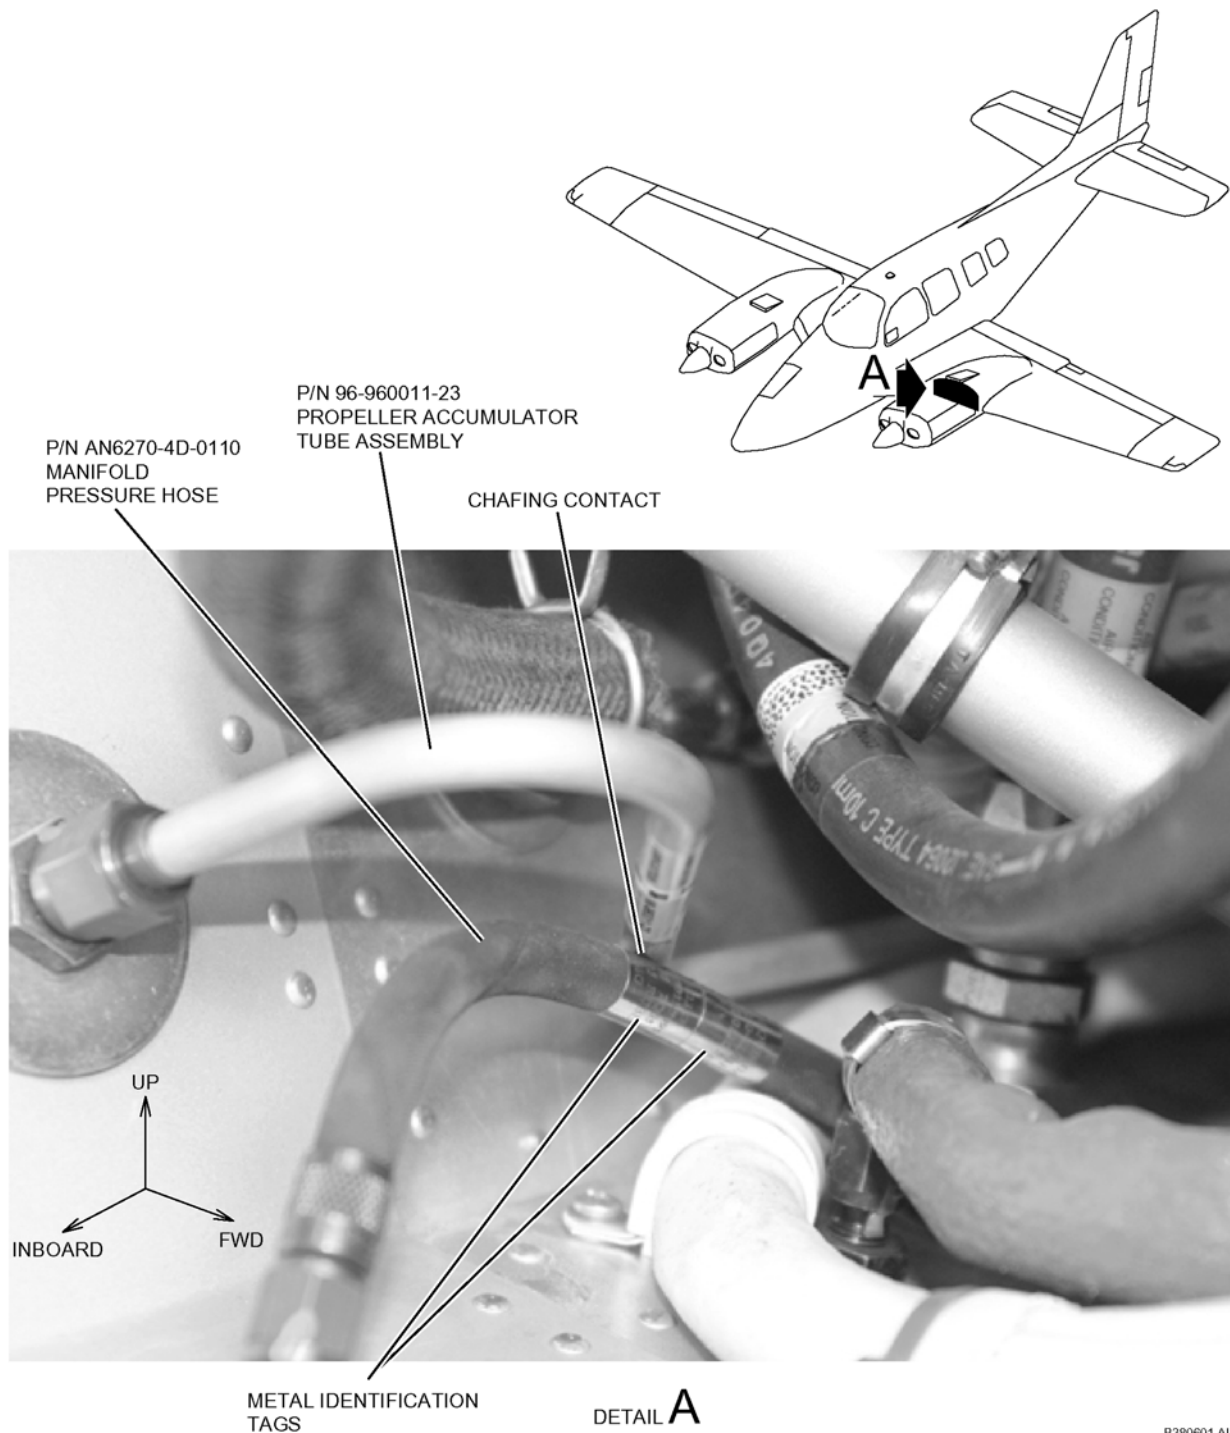
**Figure 1**

- (2) Inspect the engine manifold pressure hose and its metal identification tags for proper routing and adequate clearance to avoid any chafing with the propeller accumulator tube assembly. Refer to Figure 1.

**VIEW OF LEFT ENGINE FIREWALL FORWARD FACE SHOWING PREVIOUS HOSE ROUTING  
(LOOKING OUTBOARD)**

- (3) Inspect the propeller accumulator oil tube assembly for chafing damage, paying particular attention to the area identified in Figure 1. If any chafing damage is present, the tube must be replaced before further flight. Reference Section 1 of the BEEHCRAFT Baron 55/58 Shop Manual for torque of applicable fittings.

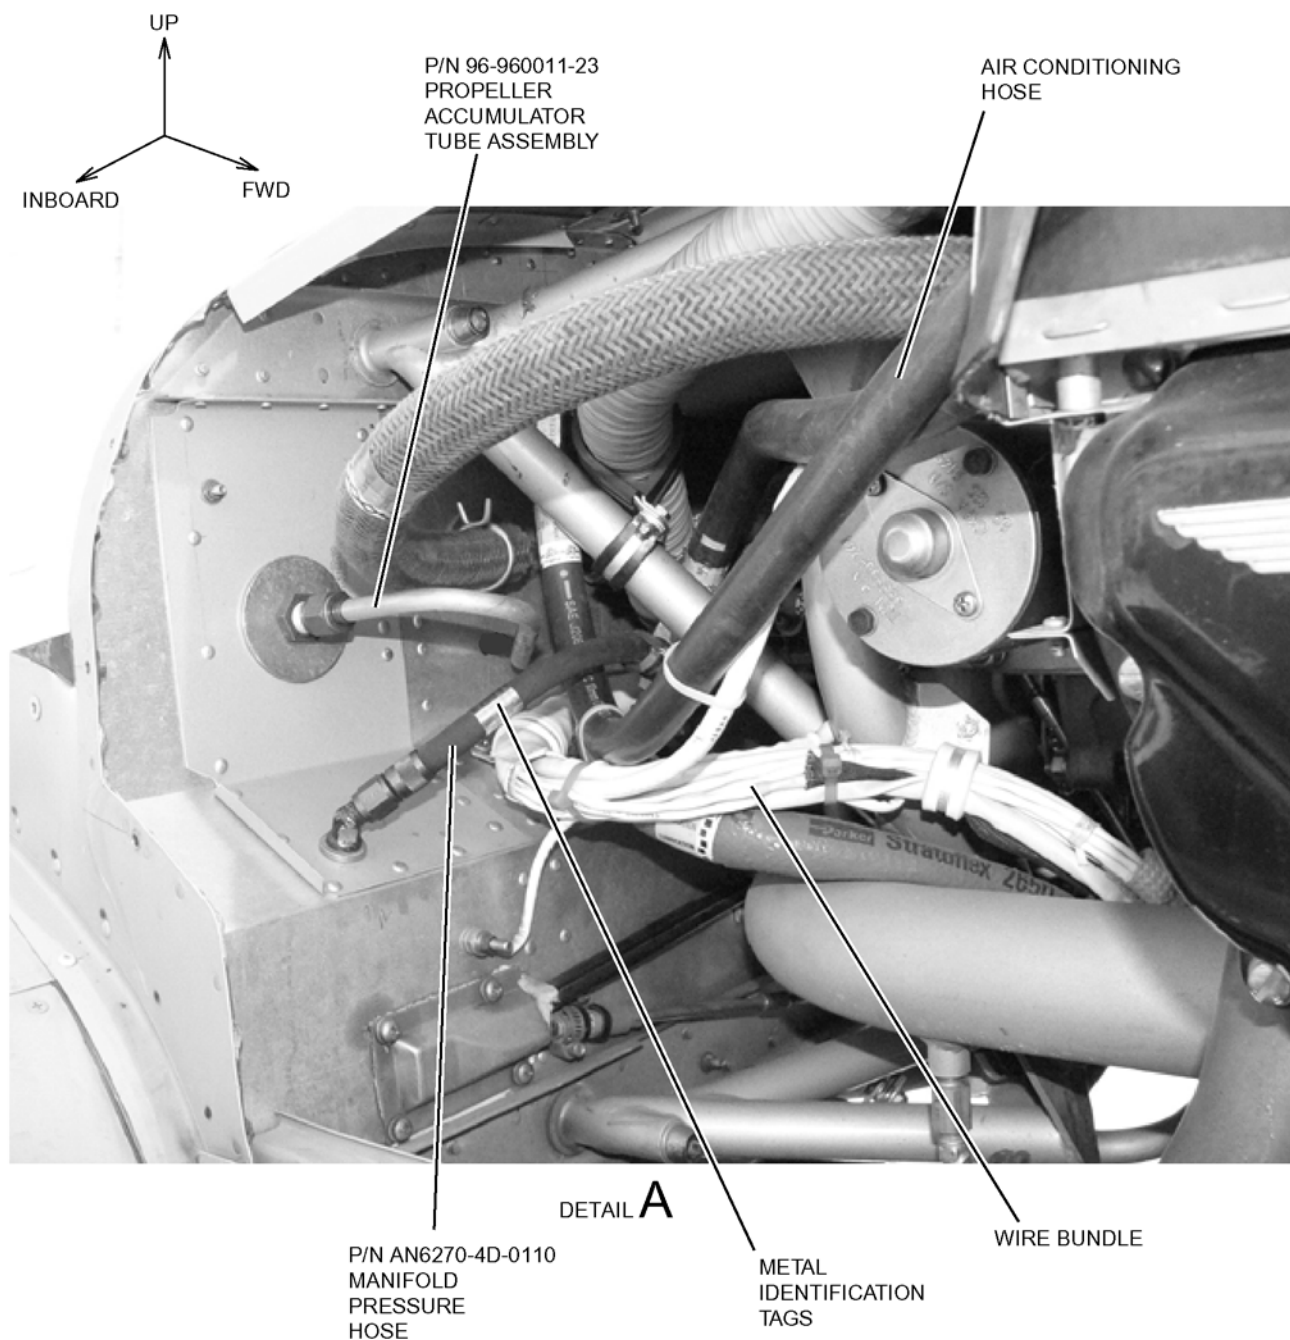
**Figure 2**

**VIEW OF LEFT ENGINE FIREWALL FORWARD FACE SHOWING NEW HOSE ROUTING  
(LOOKING OUTBOARD)**

- (4) Position (relocate) and secure both the manifold pressure hose and its metal identification tags to avoid contact with other tubes, hoses, electrical wires, parts, components and structure. Refer to Figures 2 and 3 and proceed as follows:

- (a) Disconnect the manifold pressure hose at the firewall fitting and route it above the wire bundle and air conditioning hose. Refer to Figures 2 and 3.

- (c) Attach an MS21919WDG8 clamp to the manifold pressure hose (1/2 inch) and an MS21919WDG10 clamp to the engine mount assembly (5/8 inch). Position clamp on engine mount to achieve maximum clearance with surrounding components and structure. Secure the manifold pressure hose to the engine mount assembly as shown in Figures 2 and 3. Secure the clamps together with an AN3-4A (NASM3-4A) bolt, AN960-10 (NAS1149F0363P) washer, and an MS21042-3 (NASM21042-3) self-locking nut.

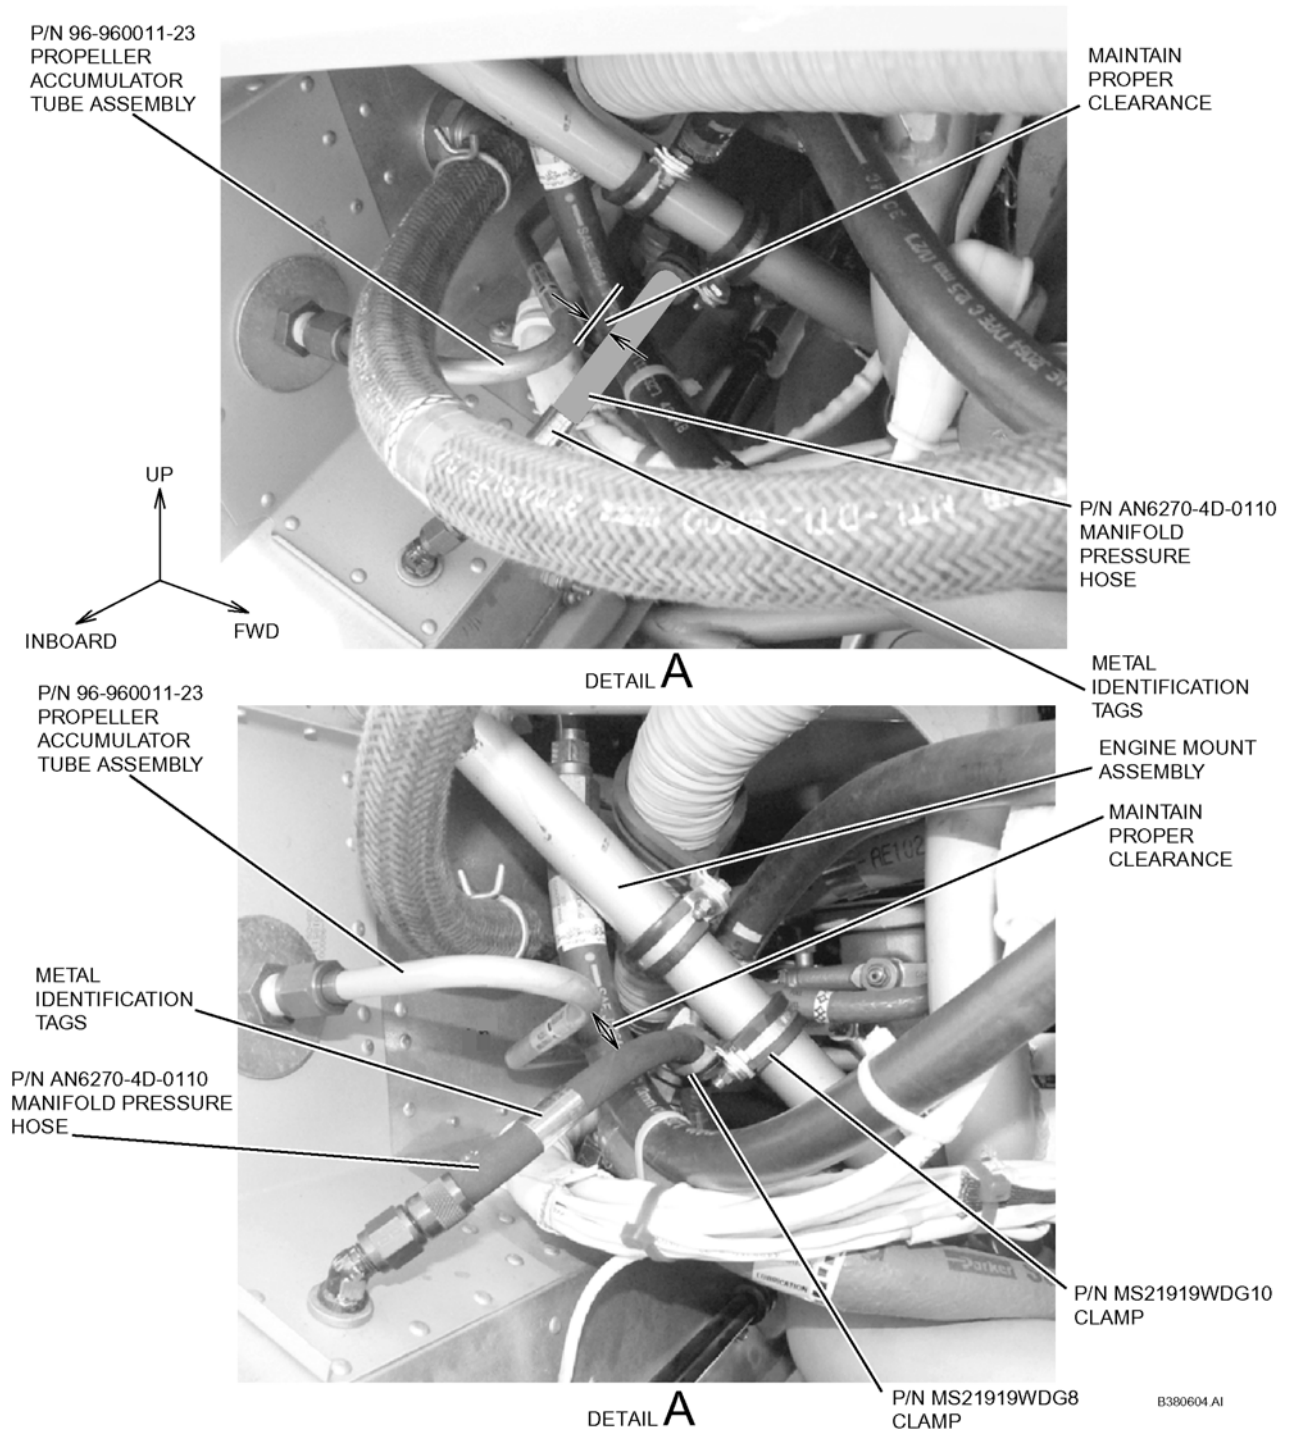
**Figure 3**

**VIEWS OF LEFT ENGINE FIREWALL FORWARD FACE SHOWING NEW HOSE ROUTING  
(LOOKING OUTBOARD)**
