## SERVICE BULLETIN

**TITLE: ENGINE CONTROLS - THROTTLE WARNING/GEAR RETRACTION PREVENTION CAM INSPECTION/INSTALLATION**

Issued: February, 2006  
Revised: March, 2006

**SB 76-3763, Rev. 1**

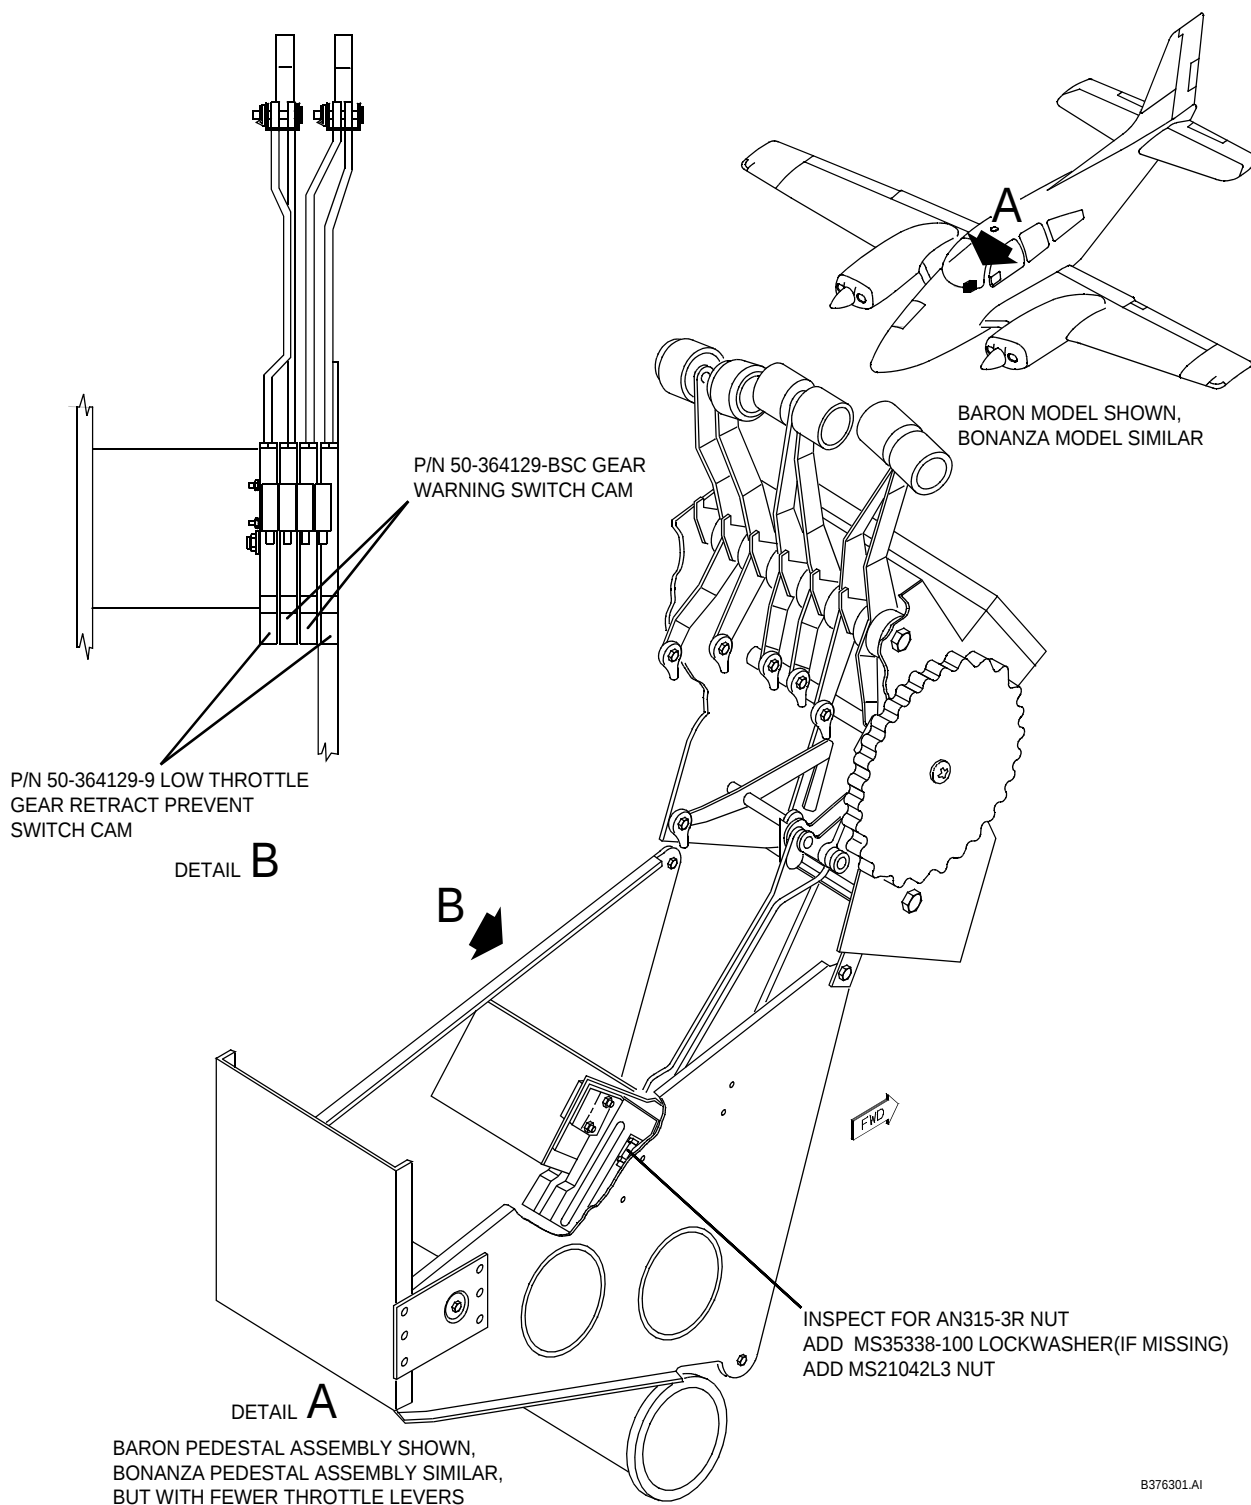
**Figure 1**

**Throttle Warning/Gear Retraction Prevention Cam Inspection/Installation**

- (1) Remove all power from the airplane and disconnect the battery. Display warning notices prohibiting reconnection of airplane electrical power.
- (2) Gain access to the airplane flight compartment and locate the pedestal assembly. Refer to Figure 1.
- (3) Remove attaching hardware and the pedestal cover. Retain attaching hardware. Locate the throttle warning switch/gear retract prevent switch cams in the pedestal assembly.
- (4) Inspect the cam actuator rods for presence of a MS35338-100 lockwasher and AN315-3R nut on the actuator rod. Refer to Figure 2.
- (5) Verify that the AN315-3R nut is torqued to 18-20 inch-pounds, not to exceed 25 inch-pounds torque. If MS35338-100 lockwasher is present and the AN-315-3R nut is properly torqued, proceed to steps (7) through (13),
- (6) Inspect for the following conditions and correct any deficient conditions:

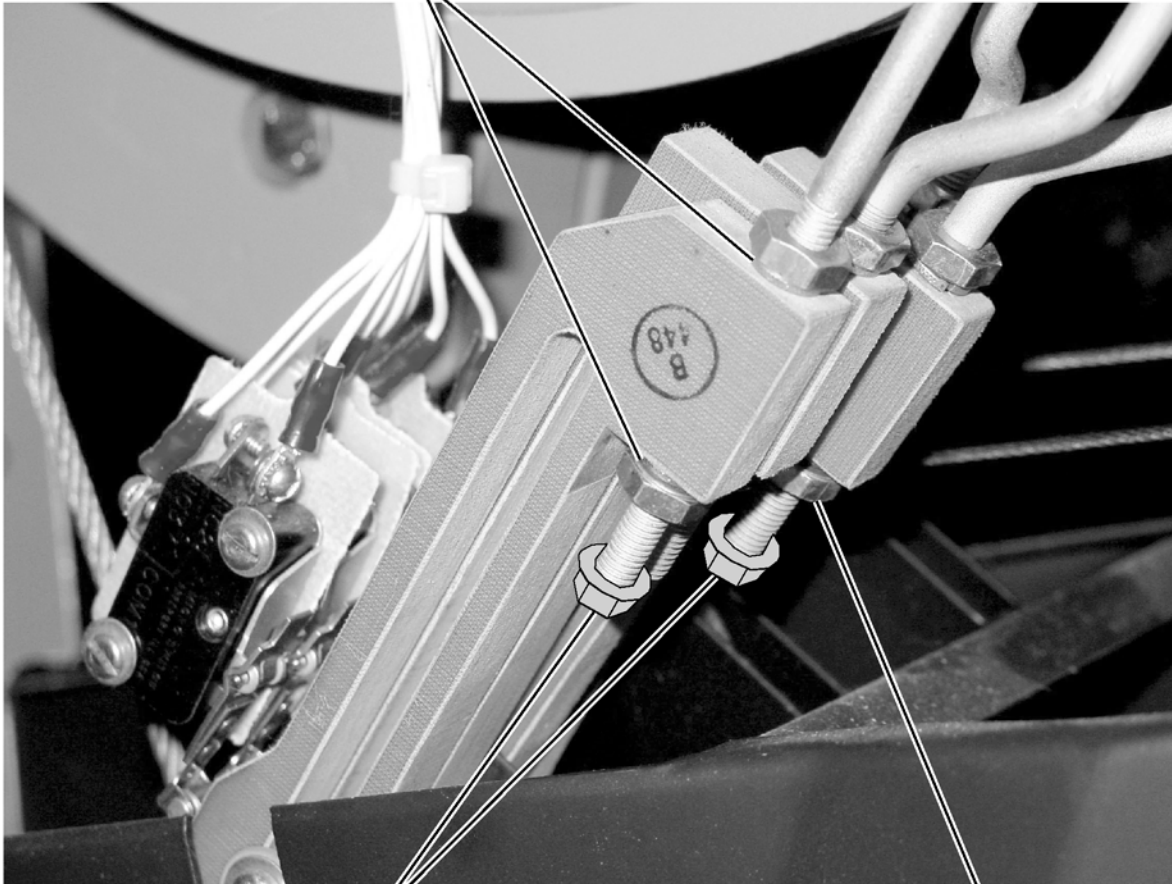
Inspection of Throttle Warning Switch/Gear Retract Prevent Switch Cams for Proper Hardware and Torque  
Figure 2

VERIFY MS35338-100 LOCKWASHER IS  
INSTALLED ON EACH CAM ACTUATOR ROD.

VERIFY AN315-3R NUT HAS NOT BACKED  
OFF AND PROPER TORQUE IS APPLIED IN  
ACCORDANCE WITH ACCOMPLISHMENT  
INSTRUCTIONS.

- (a) Lockwasher missing - If missing, remove the AN315-3R nut, install an MS35338-100 lockwasher on the throttle cam actuator rod, and reinstall the AN315-3R nut.
- (b) AN315-3R nut backed off of the actuator rod - Secure nut against lockwasher.
- (c) Proper torque - Using appropriate size torque wrench, apply 18-20 inch-pounds torque, not to exceed 25 inch-pounds torque, to the nut.
- (d) Repeat steps (6) (a) through (6) (c) for each actuator rod.
- (7) Install a new MS21042L3 or P/N 130909N29(back-up) lock nut on the end of each actuator rod. Tighten until a minimum of three threads of the throttle cam actuator rod are exposed.

INSTALL NEW MS21042L3 NUT (TYPICAL 4 PLACES)  
ON EACH THROTTLE WARNING SWITCH/GEAR  
PREVENT SWITCH CAM ACTUATOR ROD.  
TIGHTEN UNTIL A MINIMUM OF THREE THREADS  
ARE EXPOSED.

IF LOCKNUT CANNOT BE INSTALLED WITH MINIMUM  
THREAD REQUIREMENT, APPLY LOCTITE 243 THREAD  
LOCKING COMPOUND TO AN315-3R NUT AND OMIT LOCKNUT.
