SERVICE INSTRUCTIONS

No. 0546-359, Rev. II
ATA Code 24-30
Recurring Inspection

SUBJECT: ELECTRICAL POWER - ALTERNATOR - PERIODIC INSPECTION OF ROTOR SHAFT BEARINGS.

NUMBER **ASM-10** ISSUED **12-1-75**
SUBJECT **SLIP RING END BEARING INSPECTION AND LUBRICATION**
APPLICATION **ALV-9400 SERIES ALTERNATORS**
PAGE NO. **1** OF **1** PAGES

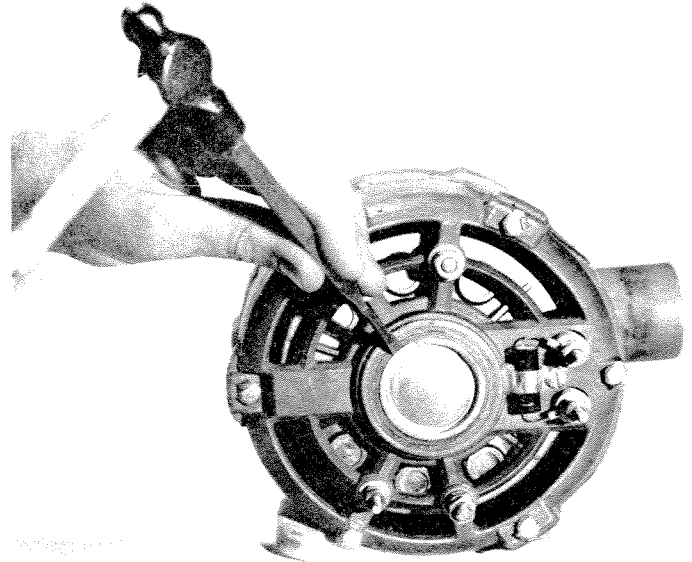
Figure 1

It is recommended that the subject bearing be inspected and, if necessary, relubricated at each 100 hour engine inspection. The subject bearing is accessible by removing the bearing cover as shown in Figure 1. Use a small sharp chisel, knife blade, or screwdriver to pry the cover out the end head. **Care must be taken not to damage the end head. If the bearing cover is damaged during removal, a new cover must be installed.**

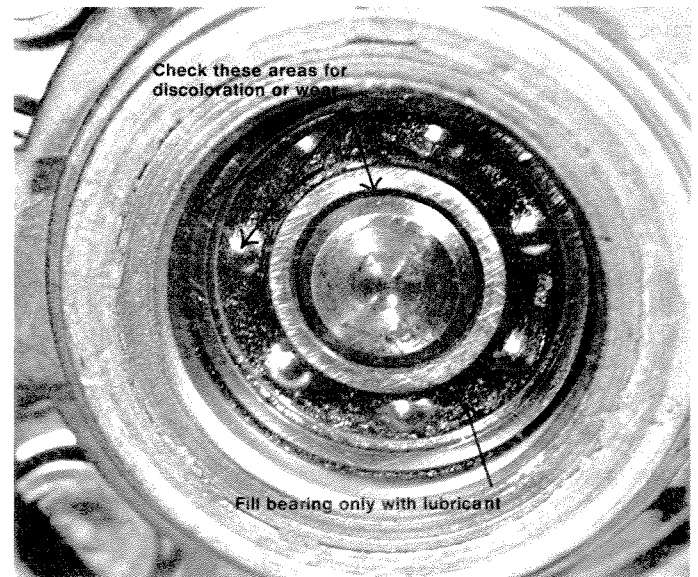
Figure 2

Without further disassembly visually inspect the bearing and shaft end for discoloration or any sign of overheating or wear. Pay particular attention to the bearing inner and outer race. See Figure 2. If there is any sign of overheating or an indication that the rotor shaft has been turning in the inner race or the outer race has been turning in the end head, the alternator must be removed and repaired.

Check the bearing grease for any sign of overheating or contamination such as dirt, or metal filings. If the grease is a dark brown or black color, or is so contaminated, the alternator must be removed and the bearing replaced.

If the rotor shaft has been turning in the bearing inner race, the rotor and bearing must be replaced. If the bearing outer race has been turning in the end head, the bearing and end head must be replaced.

If the bearing shows no sign of discoloration, overheating, wear, or contamination, fill the bearing only (not the entire cavity) with Chevron BRB #2 or Chevron SRI #2 grease, see figure 2, and replace the bearing cover. **Do not use a substitute lubricant.**
