## **Detecting and Preventing Future Aileron Cable Damage** Recommendations for Voluntary AD 2019-23-10 Follow-On Actions ABS Air Safety Foundation

December 16, 2019

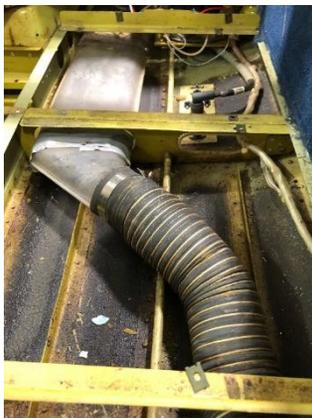
(left) Original duct

Replace the original fiberglass-impregnated ducting with double-wall silicone SCEET ducting. SCEET aids in stopping some of the condensation that drips off the heater system, and therefore makes corrosion of the cable swaged ends beneath the duct less likely. SCEET may be purchased by the foot from several different aircraft supply chains. The ducting is 2 ½ inch in diameter. You will need to purchase two feet and then cut it to the correct length for your installation. The part number at **Aircraft Spruce** is **05-30610** and is called **Vena HTD flexible duct**.

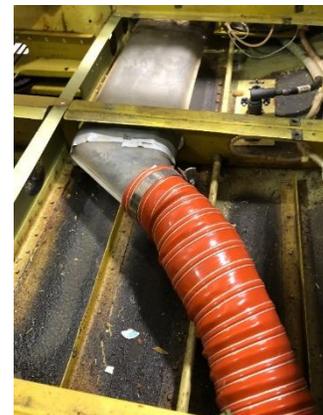
(right) New SCEET duct

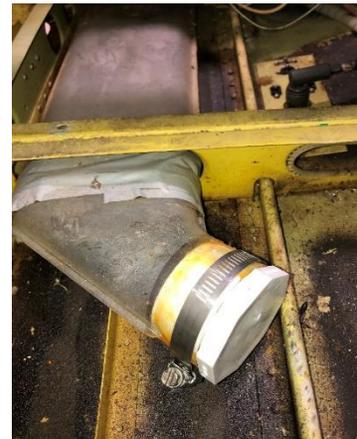
(right) Plug installed on aft heat plenum aft of the outlet for seats 3 and 4

If you do not require heat in the baggage area or aft cabin behind the 3<sup>rd</sup> and 4<sup>th</sup> seats, remove the original ducting completely. Install a 2" PVC plug (**Home Depot SKU 741 264**) inside the plenum to which the original duct is attached, then use a #36 stainless steel hose clamp (**Home Depot SKU 100 494**) to tighten the hose around the plug. The clamp and plug may also be purchased from any of the building supply stores. You will need to sand the plug's outer diameter down slightly to install it inside the flange with a tight fit.
