ABS Air Safety Foundation

## Recommended Beechcraft Control Cable Turnbuckle Inspection

Update 3 November 7, 2019

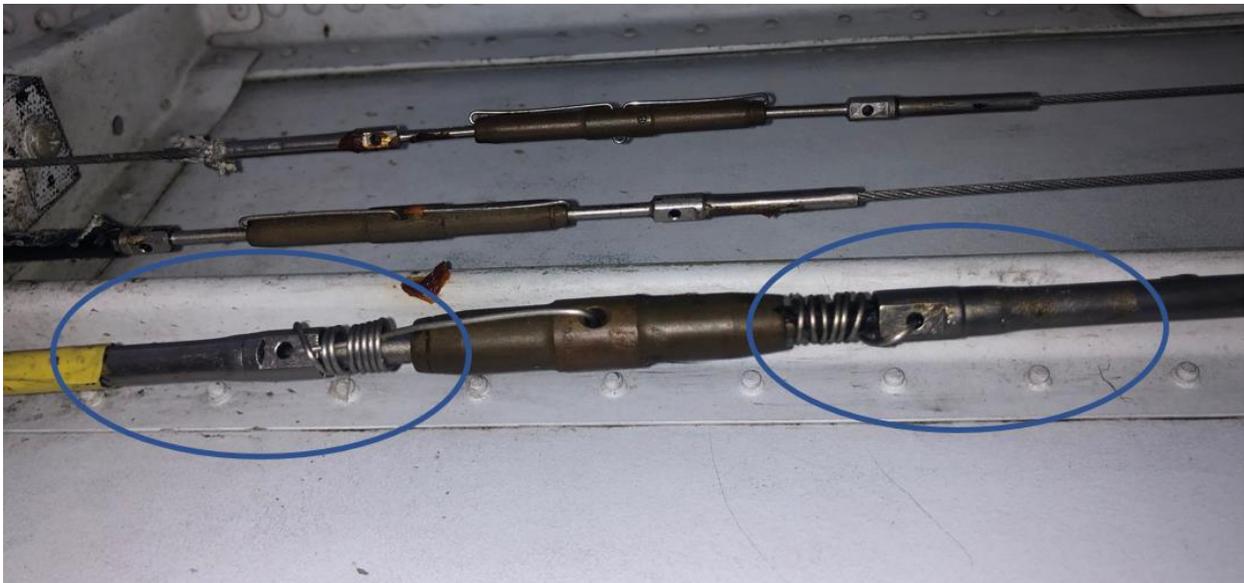
In all these cases the failure resulted from corrosion of the swaged end of the cable in turnbuckles located beneath heater ducts (in the case of the aileron cables) or beneath the overhead fresh air inlet duct in the aft fuselage (the rudder and elevator cables). ABS has also received several reports from mechanics who have found right aileron cables and turnbuckles in these areas that are very wet from condensation and lightly pitted or corroded, but that did not yet show signs of cracking.

Safety wire prevents visual inspection of the affected areas. Further, the safety wire itself tends to trap moisture and debris from the lower fuselage, potentially accelerating corrosion in the aileron turnbuckles. Safety wire must be REMOVED in order to inspect the swaged ends for the type of damage we have seen. In multiple cases the swaged ends of the cable had failed between the safety wire hold and threaded end completely and the safety wire was all that was holding it together. Later Bonanzas have turnbuckles held by clips that make visual inspection easier. Some pre-1977 airplane cables may have been replaced with the clip style turnbuckles. The aileron cable turnbuckles are located in the wheel wells post-1977 with this type of cable, which may be exposed to moisture but tend to dry from air flow in flight. Turnbuckles are in the wheel well in all vintage of Barons (which also have extended aft cabin heat) and are therefore not affected by heater duct condensation.

1. **1964-1977 Beechcraft Model 33, 35 and 36 Bonanzas, within the next 20 flight hours:**  
Inspect the right aileron control cable turnbuckle swaged ends using the procedure below:
  - a. Remove safety wire from swaged ends that use safety wire.
  - b. Visual inspect each swaged end using a 10-power magnifying glass.

- i. Any evidence of corrosion, pitting or cracking requires replacement of the affected control cables before further flight.
    - ii. If cables are replaced, use MS21251 clip style turnbuckle barrels. This makes them quicker and easier to inspect in the future and removes the safety wire that may trap moisture and promote corrosion.
  - c. Treat the swaged ends and turnbuckles with a corrosion preventative such as Corrosion X, LPS-3 or similar product.
  - d. Reinstall safety wire, if safety wire-style turnbuckle barrels are still in use.
  - e. Document the work performed in the airframe logbook. Here is a suggested logbook endorsement if no defects or damage is found:
