**SERVICE BULLETIN****Beech**

Kit No. 36-4004-1 S    Kit No. 36-4004-3 S    Kit No. 36-4004-5 S    Kit No. 36-4004-7 S  
Kit No. 36-4004-9 S    Kit No. 36-4004-11 S    Kit No. 36-4004-13 S

**TITLE:**      **FUSELAGE - WING FORWARD SPAR CARRY-THRU STRUCTURE INSPECTION AND/OR REINFORCEMENT**

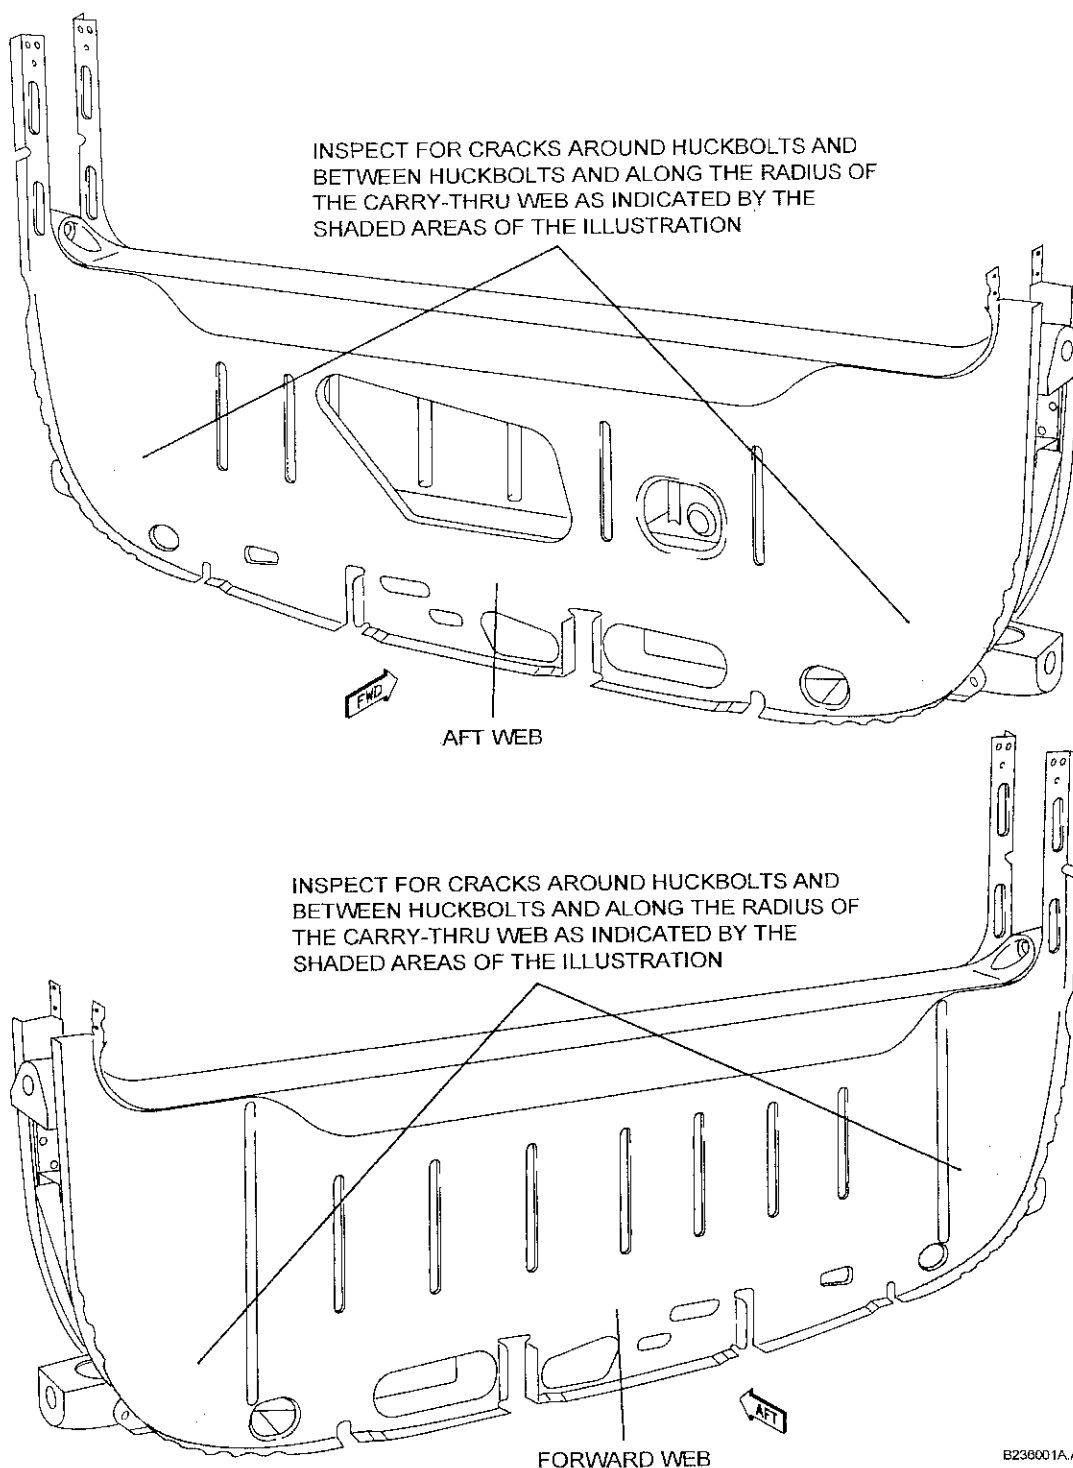
- (2) Remove the pilot's and copilot's seats and the carry-thru cover to obtain access to the front spar carry-thru structure.
- (3) Thoroughly clean the forward and aft frames (webs) of the front spar carry-thru structure in the shaded areas shown in Figure 1.
- (4) Perform a visual inspection of the area cleaned in step 3 for evidence of cracks.
- (5) Perform a dye-penetrant inspection, using visible dyes, of the area cleaned in step 3 for evidence of cracks.

Any of the shaded areas shown in Figure 1 that are modified by the installation of a doubler need not be dye-penetrant inspected until 1500 flight hours after the installation of that particular doubler. If no cracks are found, repeat the inspection every 500 flight hours.

Cracks found in the shaded areas of Figure 1 that have not been modified by a doubler must be repaired as indicated in this Service Bulletin on an individual basis.

The extent of repair is limited to cracking in the radius of the web flange and cracks in the web flat areas at the fasteners of the lower front spar cap.

Inspection for Cracks in the Wing Forward Spar Carry-Thru Structure Forward and Aft Frames

- (i) A crack up to 4.0 inches in length shall be stop drilled at the ends using a #30 drill bit. The area is to be repaired per the applicable P/N 36-4004 Kit(s) within the next 100 flight hours, 12 calendar months or the next scheduled inspection whichever occurs first.
- (ii) A crack exceeding 4.0 inches in length shall be repaired PRIOR TO FURTHER FLIGHT per the applicable P/N 36-4004 Kit(s).

- (i) A crack emanating from one fastener in two directions is considered to be one crack. **Do not stop drill, due to the possibility of damaging structure behind web face.**
- (ii) Any crack shall be repaired per the applicable P/N 36-4004 Kit(s), within the next 25 flight hours, 12 calendar months or the next scheduled inspection whichever occurs first.
- (iii) A crack passing through two fasteners and extending beyond for more than 0.5 inch on either end shall be repaired **PRIOR TO FURTHER FLIGHT**, per the applicable P/N 36-4004 Kit(s).
- (iv) A crack passing through two fasteners and extending beyond for less than 0.5 inch on both ends shall be repaired per the applicable P/N 36-4004 Kit(s), within the next 25 flight hours, 12 calendar months or the next scheduled inspection whichever occurs first.

(7) Repair all cracks per the applicable P/N 36-4004 Kit(s).
