ABS Air Safety Foundation

Beechcraft Control Cable Turn Buckle Inspection Recommendation

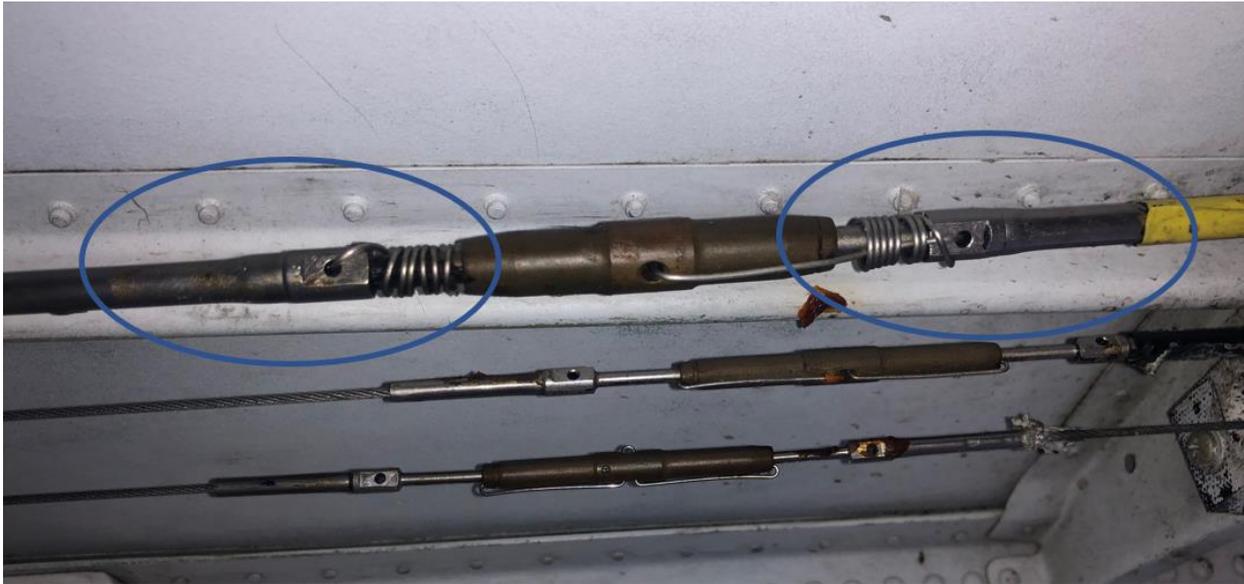
2. **At each annual inspection thereafter:** Inspect all flight control turn buckles and cables immediately adjacent to the turn buckles using the same procedure listed above.
