**ADs 90-08-04 / 95-04-03**  
**MSBs 53-2269 / 2360**

**Carry-Thru Spar Web Cracks**  
**American Bonanza Society/  
ABS Air Safety Foundation**

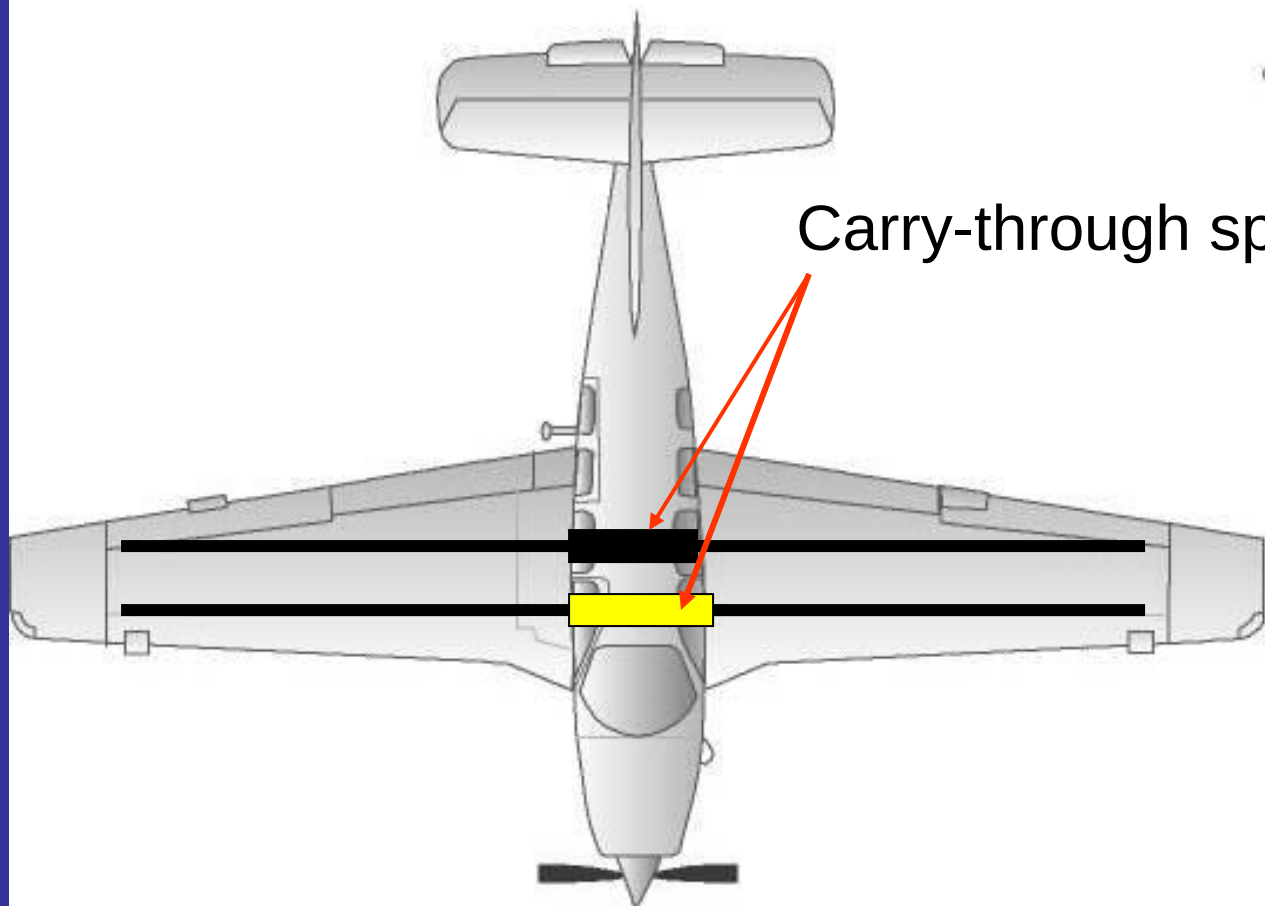
Carry-through spars

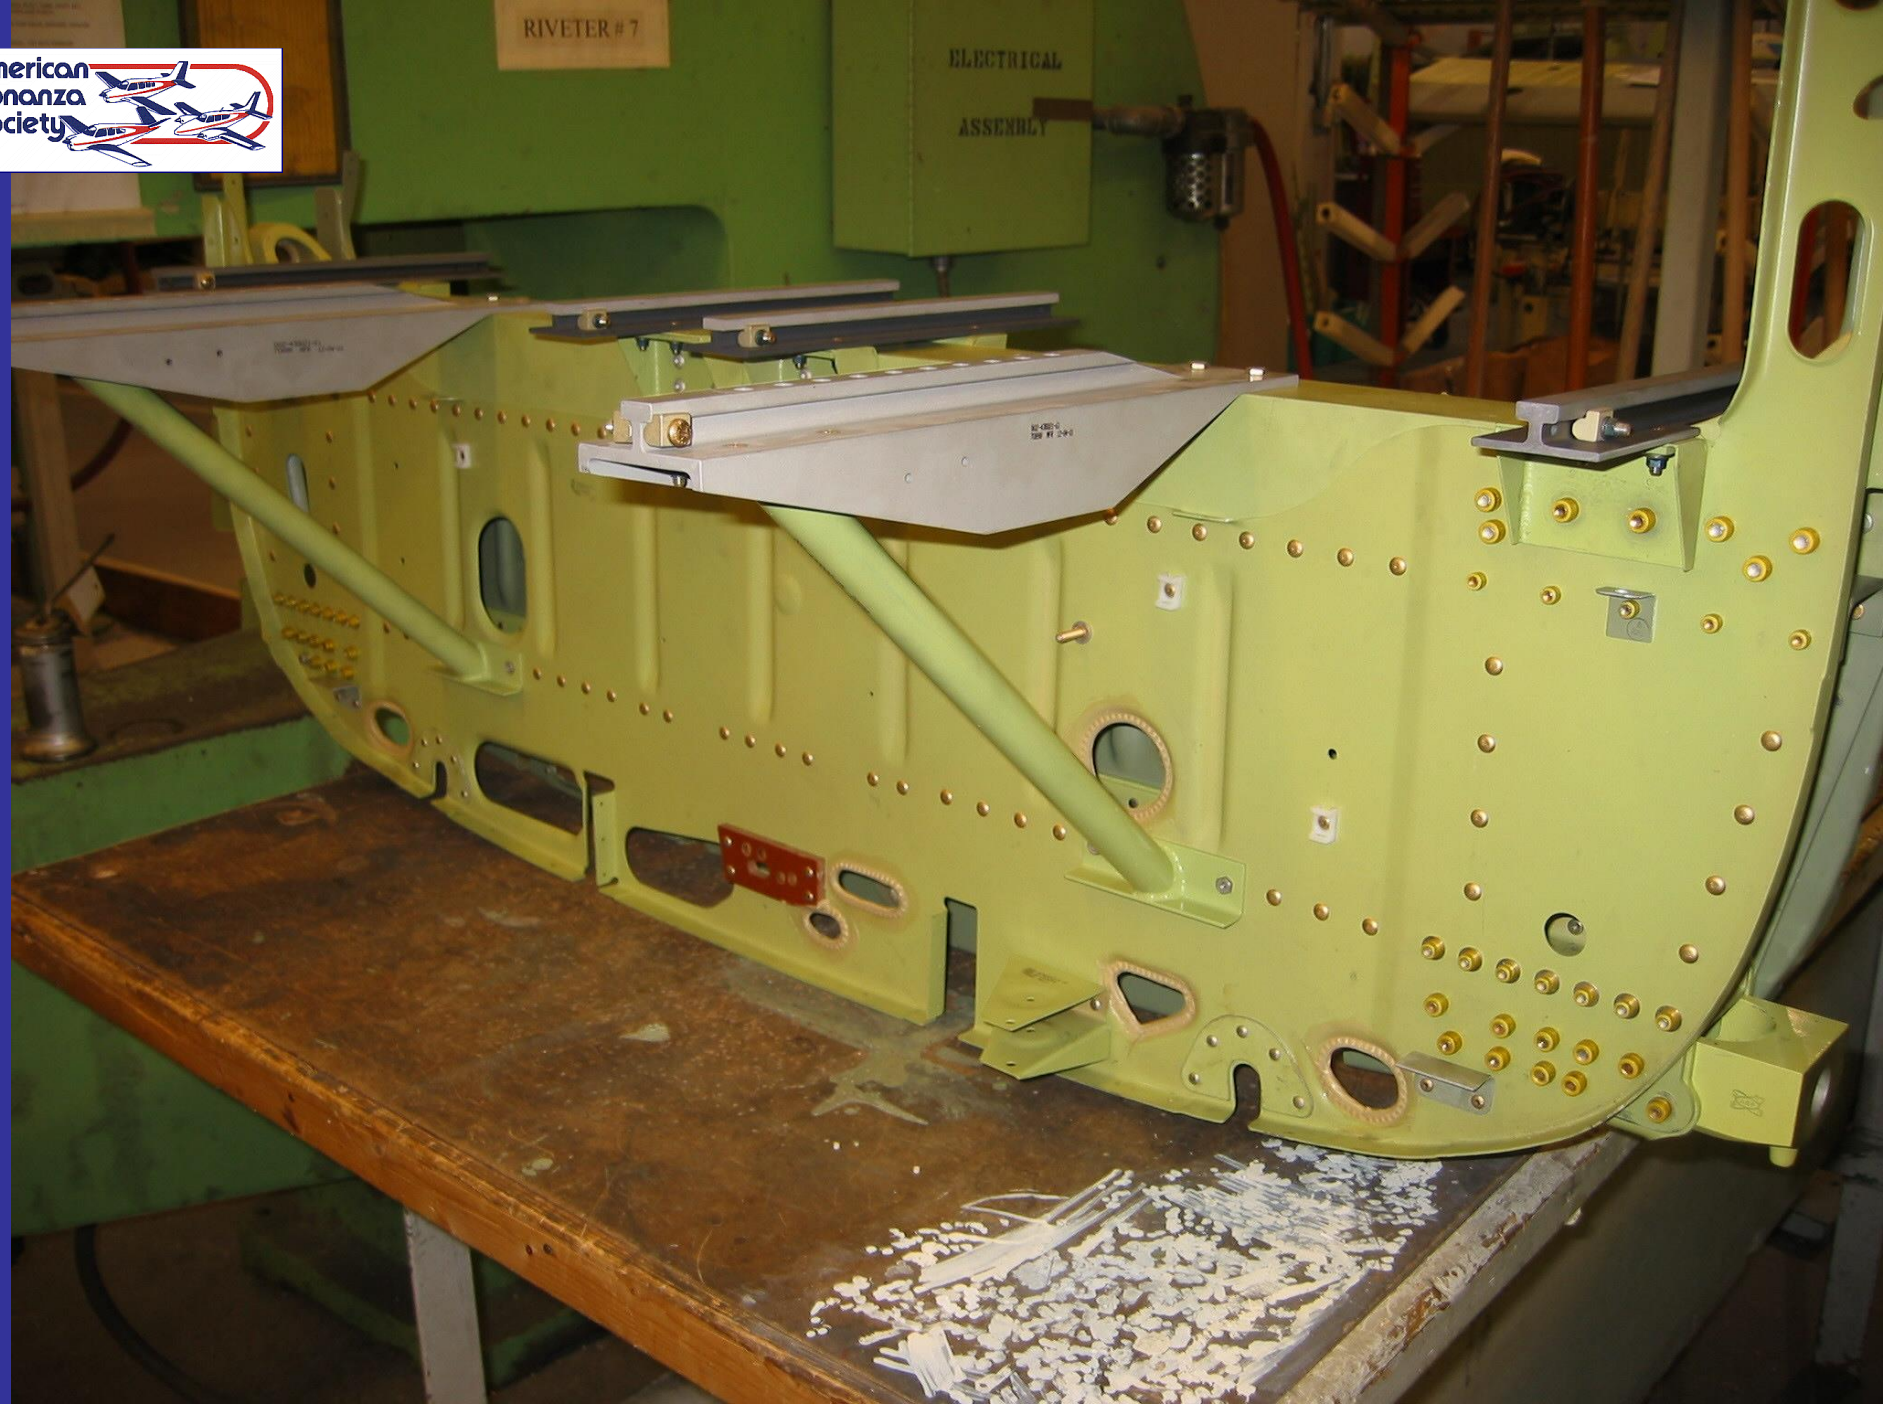
- Carry loads between ends of carry-thru in Huck bolt area
- Potential damage to tie plates and internal C-channels make stop drilling hazardous in this area
- ABS' contract engineers feel there are techniques to get around this problem
