# Safety Communique

January, 2011

**SUBJECT:** FLAP ACTUATOR ATTACHMENT BRACKET AND NOSE RIB ASSEMBLY

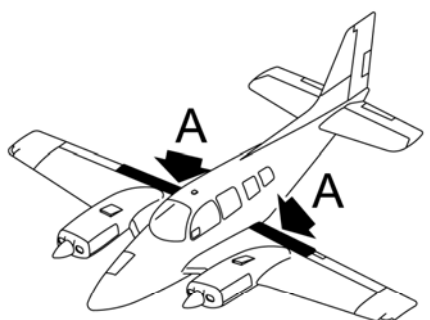
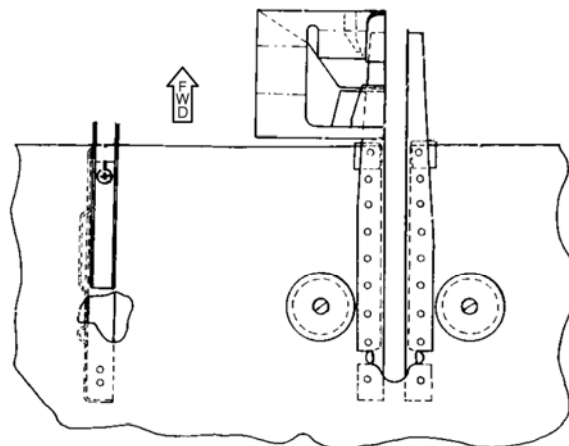
**Nose Rib Assembly Crack Location  
Figure 1**

HBC has received ten reports from the field of crack damage on the part number (P/N) 35-165050-84 nose rib assembly for the flap actuator attachment bracket. Refer to Figure 1. In October 2007, a pilot reported a split flap condition during flap extension to a 14 CFR Part 145 repair station. The repair station found the flap actuator mounting plate cracked. The mounting plate is secured to the flap by three screws, which are attached to the nose rib assembly by nutplates. Further inspection of the flap revealed cracks in this nose rib. Since the repair station regularly performed inspections on several models of HBC airplanes, they began paying particular attention during inspections to these areas and submitted six service difficulty reports on Model 33, 35, 36, and 95 airplanes. In January 2008, Advisory Circular 43-16A was issued detailing these reports. The flap actuator mounting is of similar design on all of the reported airplanes. Through May 2010, this repair station addressed four additional service difficulty reports for cracks found on the same part number nose rib assembly.

A review of the ten reports identified affected airplanes as having between 4,000 and 6,500 flight hours (total time in service). Most of the affected parts were right flap parts, located adjacent to the cabin entrance. However, cracks have been found on the same nose rib on the left side nose rib assembly.

Flap leading edge nose rib and/or the flap actuator mounting bracket cracking has the potential to cause the part to become disconnected, and could result in a split flap condition.

BARON SHOWN, OTHER MODELS SIMILAR

VIEW LOOKING DOWN ON  
FORWARD EDGE OF FLAP

HBC reminds maintenance facilities of the importance of adhering to existing inspection and maintenance procedures in the applicable airplane series Maintenance Manual or Shop Manual and specified spare parts in the applicable Illustrated Parts Catalog when replacing components during routine maintenance.
