SERVICE BULLETIN

TITLE: NAVIGATION - GARMIN G1000 SYSTEM UPGRADES INCLUDING TERRAIN AWARENESS AND WARNING SYSTEM (TAWS-B) FUNCTION PER STC SA01725SE

SYNOPSIS OF CHANGE

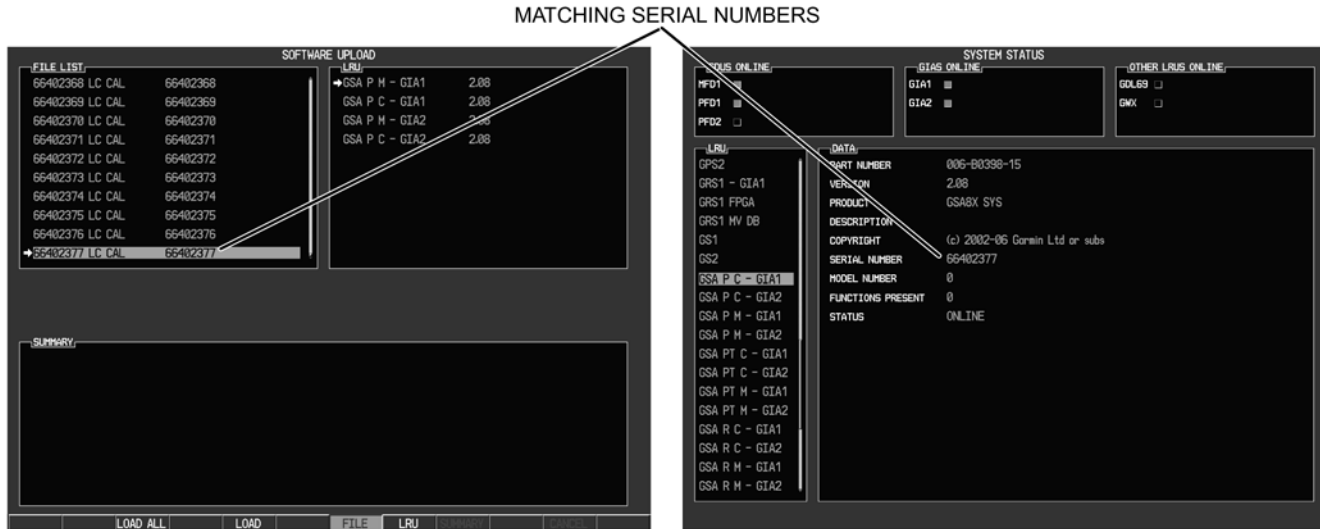
B385904.AI

(h) Using the small FMS knob, turn to the SOFTWARE UPLOAD page on the PFD. See the following figure for example screenshots.

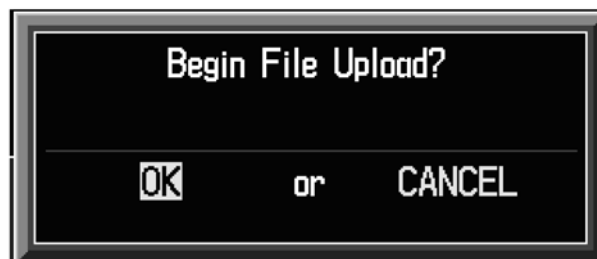
B385905.AI

- (i) On the MFD, press the small FMS knob to activate the cursor then scroll down and highlight the Pitch Servo in the LRU field (e.g. GSA P C - GIA1).
- (j) On the PFD, use the small FMS knob to highlight the matching serial number in the FILE LIST.
- (k) Press the LOAD softkey.
- (l) Select 'OK' at the "Begin File Upload?" prompt and press the ENT key.

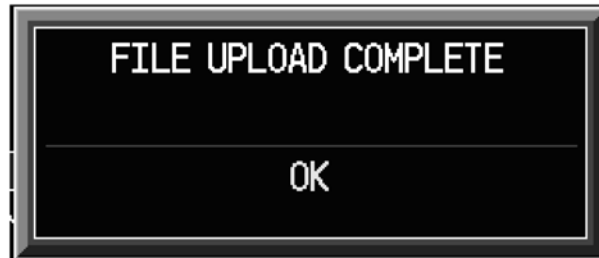
B385906.AI

- (m) When the file finishes uploading, a “FILE UPLOAD COMPLETE” prompt appears. Press the ENT key to confirm.

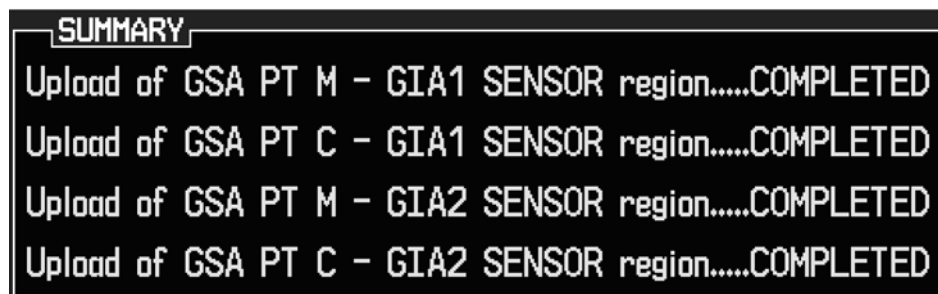
B385907.AI

- (n) Repeat Steps (6)(i) through (6)(m) for the remaining Roll (R), Yaw (Y), and Pitch Trim (PT) Servos (as applicable). Note the progress of the uploads in the Summary Field on the PFD.

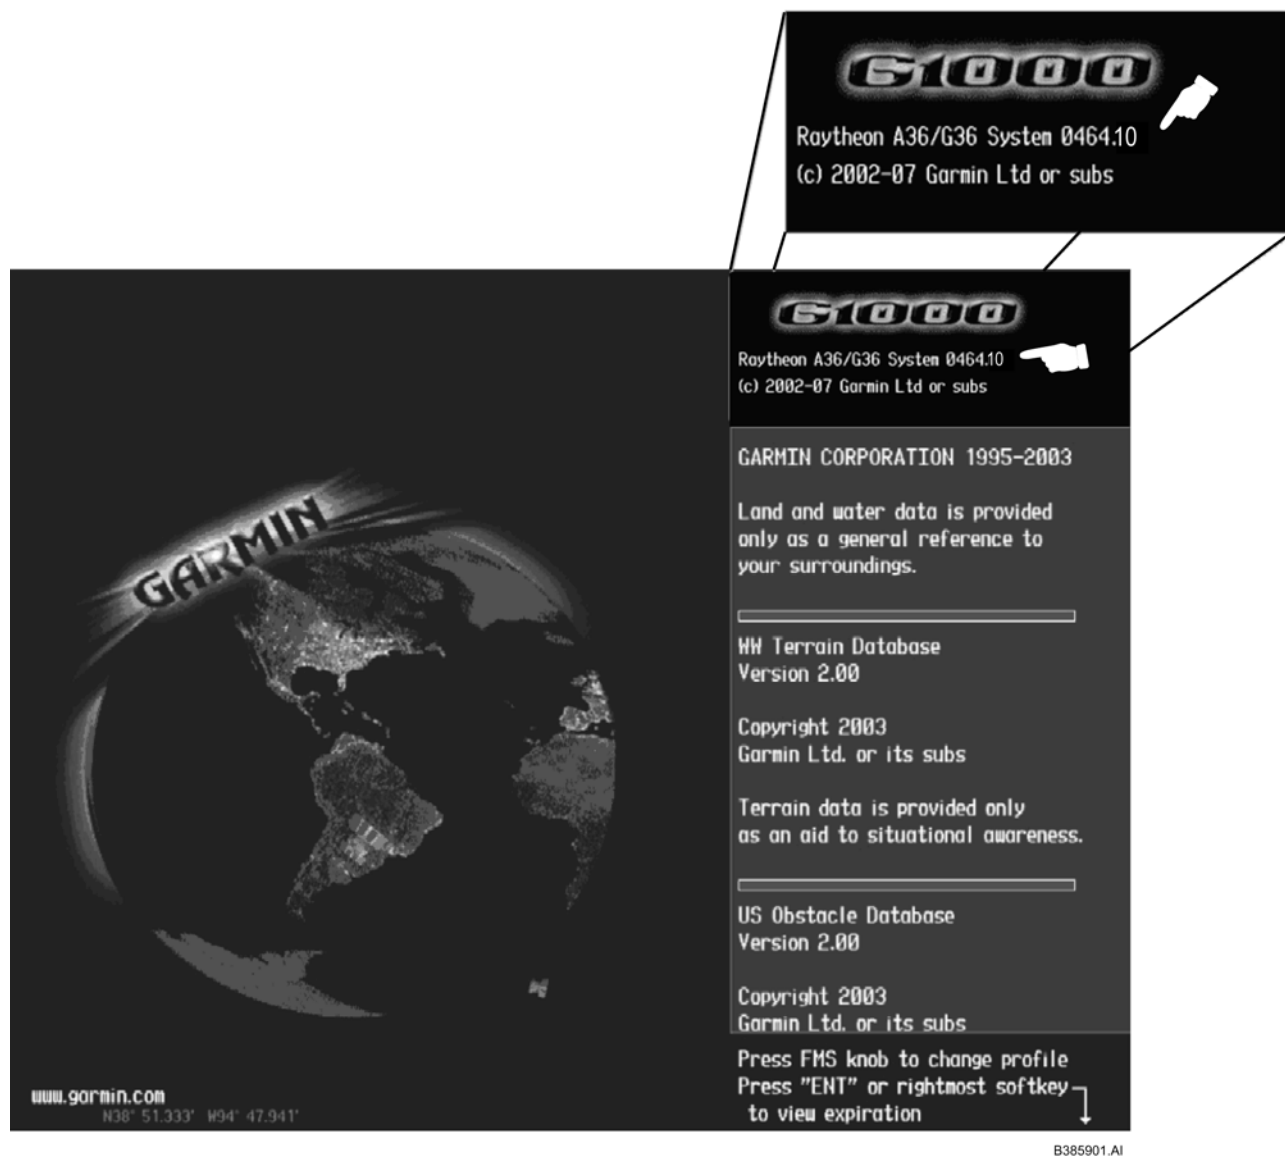
MFD Power-Up Screen
Figure 1

- (1) VERIFY AIRFRAME SYSTEM SOFTWARE VERSION:
 - (a) Connect a 28-VDC external power unit to the airplane in accordance with Section 24 of the Bonanza Series Maintenance Manual.
 - (b) Start the system in normal mode by turning on the BAT 1, BAT 2 and AVIONICS switches.
 - (c) Look at the MFD power-up screen (refer to Figure 1) in the upper right corner, the number displayed is the AIRFRAME SYSTEM SOFTWARE VERSION, e.g. 'Raytheon A36 / G36 System 0458.04' or '0464.08'. If any other AIRFRAME SYSTEM SOFTWARE VERSION is displayed, this Service Bulletin is not applicable.
 - (d) If the MFD display shows A36 / G36 System 0458.04, remove power from the MFD and PFD and proceed to Step (2) LOAD BOOT BLOCK VERSION 4.01. **If the AIRFRAME SYSTEM SOFTWARE IS VERSION 0464.08 proceed to Part II of this Service Bulletin.**
- (2) LOAD BOOT BLOCK VERSION 4.01:
