V-Tail Fact Sheet - 35 through B35 (including 35R)

APPLICABLE AIRWORTHINESS DIRECTIVE: AD 2002-21-13

AFFECTED AIRPLANES All 35, A35, B35 and 35R airplanes.

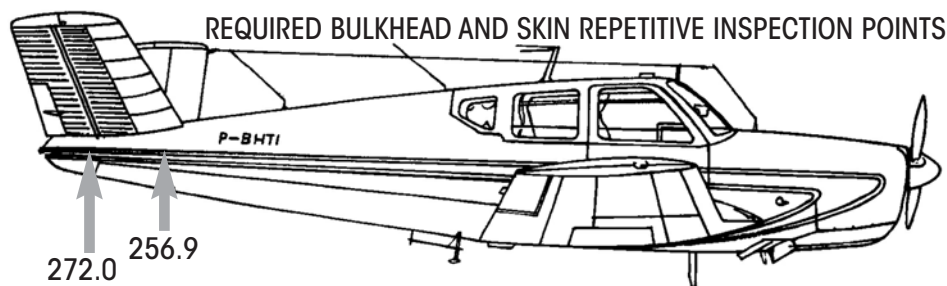
- inspecting the empennage, aft fuselage and ruddervator control system controls, and repair as necessary before further flight.
