# V-Tail Fact Sheet - C35 through V35B

## APPLICABLE AIRWORTHINESS DIRECTIVE: AD 94-20-04 R2

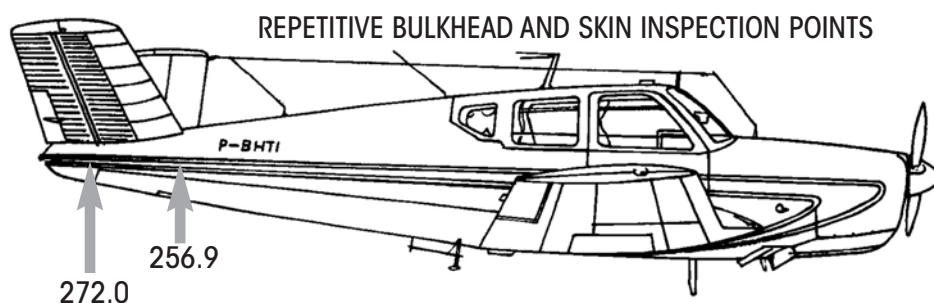
- visual inspection of the bulkheads and skin at fuselage stations 256.9 and 272.0 for damage, and repair as necessary.
